96-19-01 - Access-Start Authorization (KESSY) - Keyless Defective Message in Instrument Cluster

Release date: 9/XX/2020

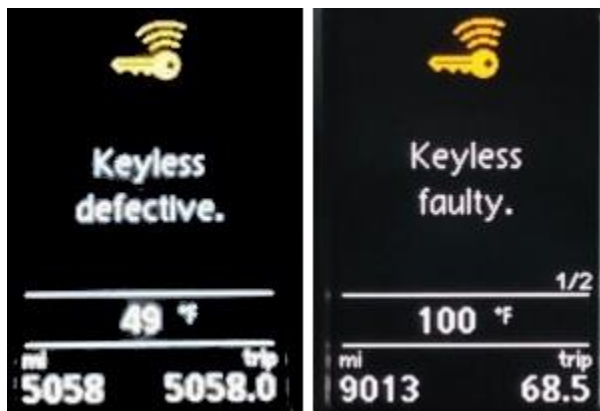
Figure 1.

The customer reports that the warning message “Keyless defective” or “Keyless faulty” has appeared in the instrument cluster after starting the engine (Figure 1).

A software-related deviation in the Access/Start Authorization Control Module **-J518-** allows false detection of an open circuit condition during engine cranking.

Using software version management (SVM), update the software of the Access/Start Authorization Control Module.
