# Technical Service Bulletin

## 26 Droning, buzzing, or vibration from front of the vehicle - Q7

26 20 41 2058574/3 September 4, 2020. Supersedes Technical Service Bulletin Group 26 number 20-38 dated March 11, 2020 for reasons listed below.

Model(s)	Year	VIN Range	Vehicle-Specific Equipment
Q7	2019	023480 - 999999	3.0TFSI

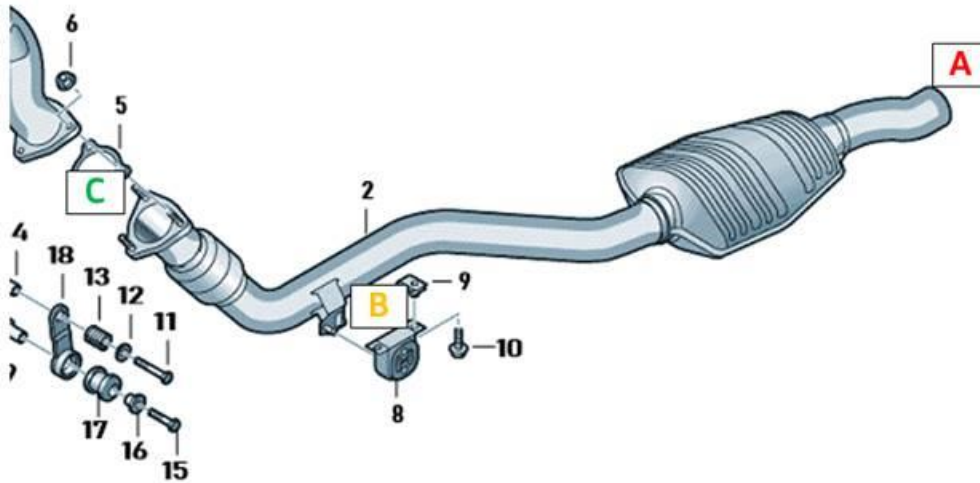
- Droning, buzzing, or vibration; especially between 1,000 – 1,400 rpm.

- The issue can be isolated to underside and front of the vehicle.

1. Verify exhaust downpipes as the source of the customer concern. In most cases the exhaust downpipes only need adjustment.

*Figure 1. Example of locations to loosen and tighten.*

2. Loosen the exhaust following the method below:

- Loosen the exhaust clamp (A), exhaust bracket (B).
- Then re-tighten beginning with clamp (A) and then the bracket (B) (Figure 1).

3. Test drive and if issue persists continue with the following step (Figure 1):

- Repeat and loosen the exhaust at (A), (B), and also the flange (C) to the catalytic converter.
- Then tighten in the following sequence: First, the flange (C), second the exhaust clamp (A), and finally the exhaust bracket (B).
