38 Oil is leaking from the transmission

38 20 18 2060563/1 September 11, 2020.

Model(s)	Year	VIN Range	Vehicle-Specific Equipment
Q3	2019 - 2021	All	09P Transmission

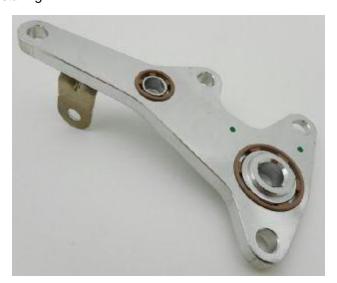
Figure 2. ATF cooler adaptor example.

Assembly error damaged the ATF cooler adaptor seals.

- 2. If the leak is not from the ATF cooler adaptor, this TSB does not apply and you should continue your diagnosis.
- 3. If the leak has been confirmed from the ATF cooler adaptor, replace the ATF cooler adaptor with seals per the repair manual, *Drivetrain >> 8-Speed Automatic Transmission 09P >> 37 Controls, Housing >> ATF Circuit >> ATF Cooler Adaptor, Removing and Installing.*
- Pay special attention to the seals when installing the ATF cooler adaptor. The seals must be in correct position as shown (Figure 2) or the leak will return.

- 5. Correct the level of the ATF per the repair manual.
- 6. Test drive after repair and confirm the leak is repaired.
