92-20-01TT - Windshield wiper operation with fault B12D600, may occur in heavy rain

Release date: 09/18/2020

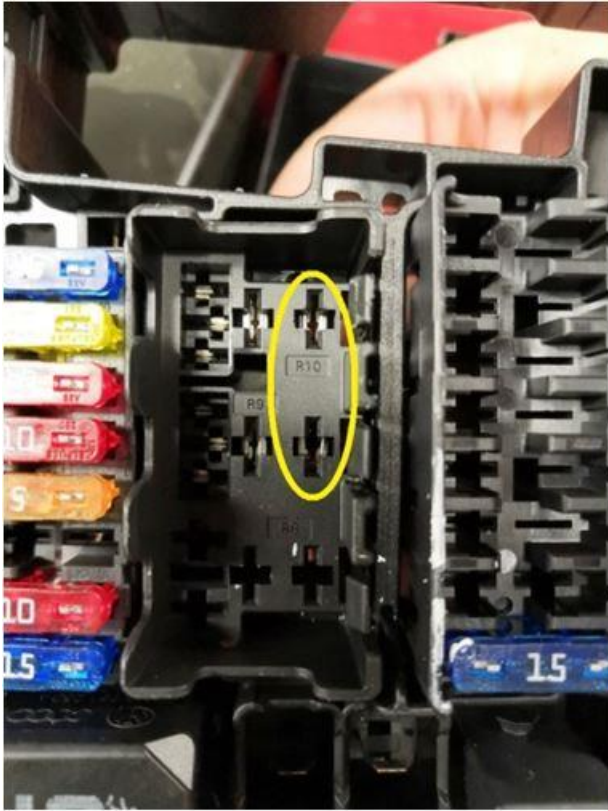
Figure 1

Wipers may have an operational issue, which may occur in heavy rain. Faults may include but are not limited to B12D600, U014100, U112100, U111000.

Inspect the wiring for wiper relay 1 -~~J368~~ and wiper relay 2 -~~J369~~ at the under the hood relay panel. Test the terminals by performing a pin drag test, including the connecting circuit between these relays (Figure1). If a terminal issue is found for this connecting circuit, install a new connecting circuit, (Figure 2) with new terminals. See Repair Group 97 in Elsa.
