Technical Service Bulletin

48 Intermediate steering shaft boot is not properly sealing the engine exhaust noises

48 20 89 2059704/2 September 2, 2020. Supersedes Technical Service Bulletin Group 48 number 20-88 dated June 8, 2020 for reasons listed below.

Model(s)	Year	VIN Range	Vehicle-Specific Equipment
Q7	2017 - 2018	All	Not Applicable

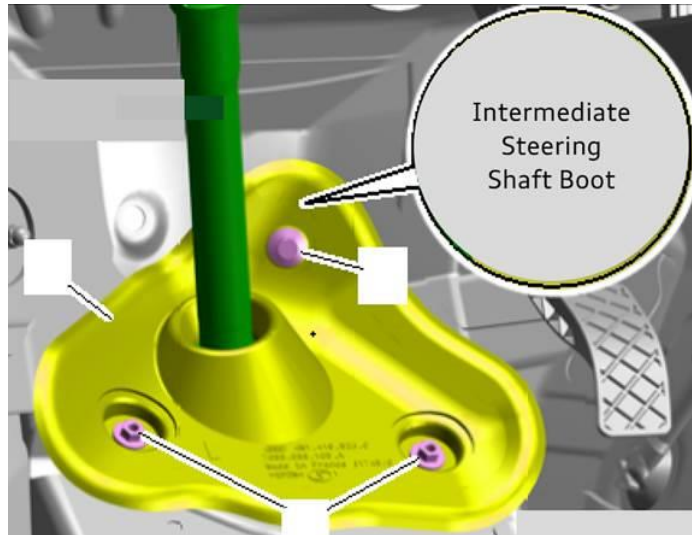
- The rubber boot from the intermediate steering shaft is not properly sealing the firewall.

1. From inside the vehicle place a shop rag/towel around the intermediate steering shaft in the area where it passes through the boot, also covering the entire boot (Figure 1).

Figure 1. Intermediate steering shaft boot.

2. If the noise is reduced or is no longer present, the intermediate steering shaft should be replaced according to Elsa at Repair Manual, Elsa at Repair Manual, *Chassis >> Suspension, Wheels, Steering >> 48 Steering >> Steering Column >> Steering Intermediate Shaft; Removing and Installing.*
3. If the noise is unchanged, continue with normal diagnosis including inspecting for other body sealing issues (e.g. loose or missing harness grommet).
