Technical Service Bulletin

51 Water sloshing sound is heard while driving

51 20 15 2060609/1 September 15, 2020.

Model(s)	Year	VIN Range	Vehicle-Specific Equipment
Audi e-tron Sportback	2020	All	Not Applicable
Audi e-tron quattro	2019 - 2020	All	Not Applicable

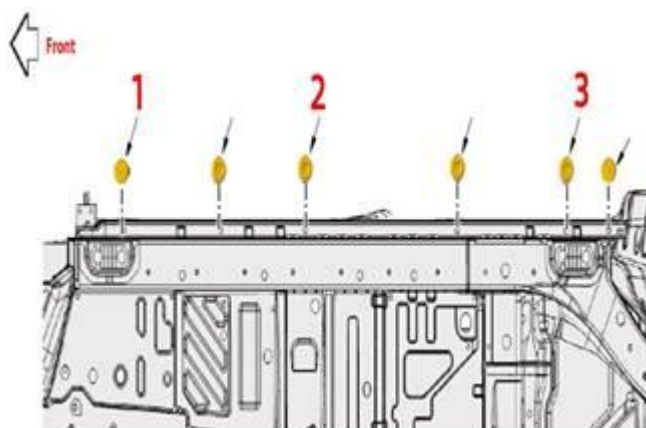
- Water is found to have accumulated in the cavities contained in the side sills.

It is possible over time for water to accumulate in the side members and sills but the water is not able to drain as needed. This accumulated water creates a 'sloshing' noise when the vehicle moves.

Figure 1. Plugs to be removed from the side sills.

1. Test drive the vehicle preferably with the customer and duplicate the symptom. If the symptom is duplicated, raise the vehicle on the hoist and remove the sill plugs on both sides of the vehicle numbered 1, 2 and 3 on each side (Figure 1).

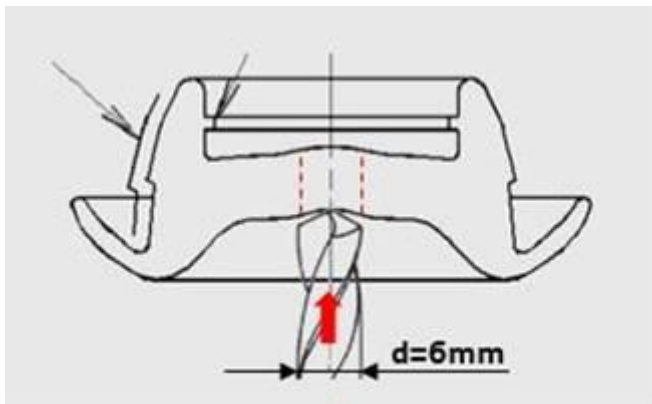
Figure 2. Drilling a 6mm hole in the center of the removed plugs.

2. Drill a hole 6mm in diameter in the center of each plug removed (Figure 2).

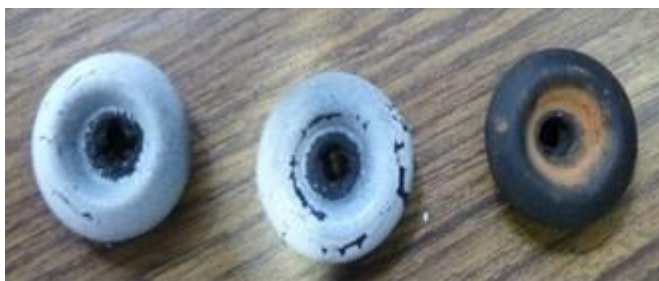
Figure 3. Modified sill plugs with 6mm hole drilled.

3. Spray conservation wax D 330 KD2 A1 - or- D 321 M16 M2 into the sill cavities through the openings left from the removed plugs. Install the modified plugs back into their openings (Figure 3).
