# Technical Service Bulletin

## 91 MIB2 High Scale: Bluetooth call distorted audio or black screen for Apple CarPlay after using backup camera

91 20 07 2046294/5 September 2, 2020. Supersedes Technical Service Bulletin Group 91 number 20-82 dated July 10, 2020 for reasons listed below.

Model(s)	Year	VIN Range	Vehicle-Specific Equipment
A4	2017	All	MMI Radio Plus

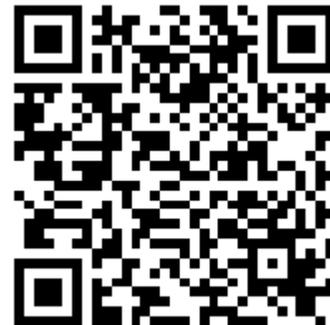
- When using Bluetooth hands-free calling the caller hears distorted audio from the driver that can be described as a “robotic or electronic sound”. To hear two examples of the distorted audio during a Bluetooth call, see the video located at: <https://audi-external.kzoplatform.com:443/swf/player/336> (Figure 1).

Figure 1. QR code for an example of the clicking noise.

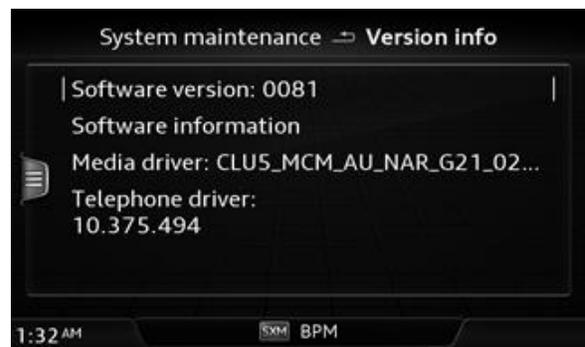
1. Verify the customer's MMI requires the software update by going to the *Main Menu >> Settings >> Left drawer option >> Version Information* (Figure 2).

Software versions 0061 & 0081 are only the versions that can be updated. If the MMI is at level 0110, 0116, or 0118, then this TSB does not apply. Cars built after CW22/16 have SW0110 and these vehicles are NOT compatible with this software. Updating a car with SW0110 can damage the MMI.

Figure 2. MMI Version Information

- Update the MIB2 High Scale infotainment system using either Method 1 or Method 2 according to TSB 2050565: *91 MIB2 High Scale Software Update Instructions (PR Code 7UH)* and use SVM code MHS2US0138.
