# Technical Service Bulletin

## 91 MIB2 High Scale: Apple CarPlay cannot be started or MMI screen goes blank after iPhone is connected to USB

91 20 12 2050569/2 September 3, 2020. Supersedes Technical Service Bulletin Group 91 number 18-81 dated February 28, 2018 for reasons listed below.

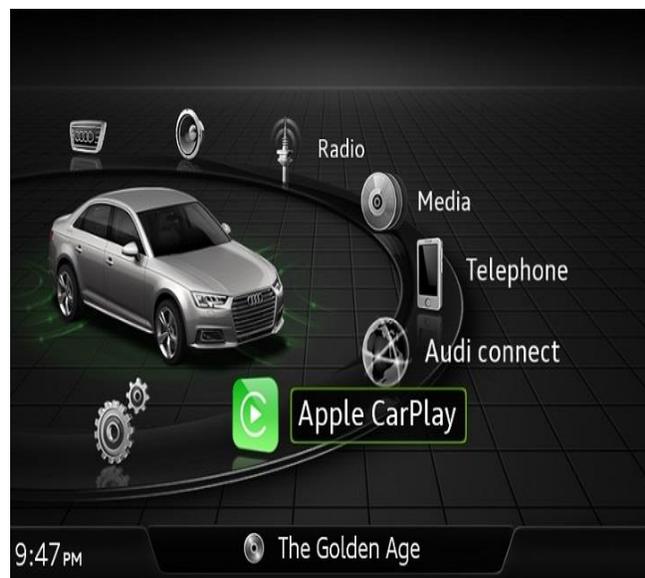
- After reversing the Audi smartphone interface (ASI) menu cannot be selected any more, although the music is still playing (Figure 1). The customer has the MIB2 High Scale infotainment system (PR Code 7UH) and the vehicle is built after CW22/16.

Figure 1. Audi Smartphone Interface menu.

The MIB2 High Scale infotainment system (PR Code 7UH) has a known software issue which can cause the MMI screen to either turn black when Apple CarPlay is initialized or can cause an issue where the user can no longer start Apple CarPlay. When the Apple CarPlay menu option is selected the screen will flash briefly to a blank screen and then return to the main menu as seen in Figure 1. The software update provided only applies to cars built after CW22/16. For cars built before CW22/16, please see the following TSBs:

- Update the MIB2 High Scale infotainment system using either Method 1 or Method 2 according to TSB 2050565, *91 MIB2 High Scale Software Update Instructions (PR Code 7UH)* and use SVM code MHS2US2037.
