Technical Service Bulletin

91 Parking assist alert showing an active false positive, various DTCs may be stored

91 20 14 2060675/1 September 17, 2020.

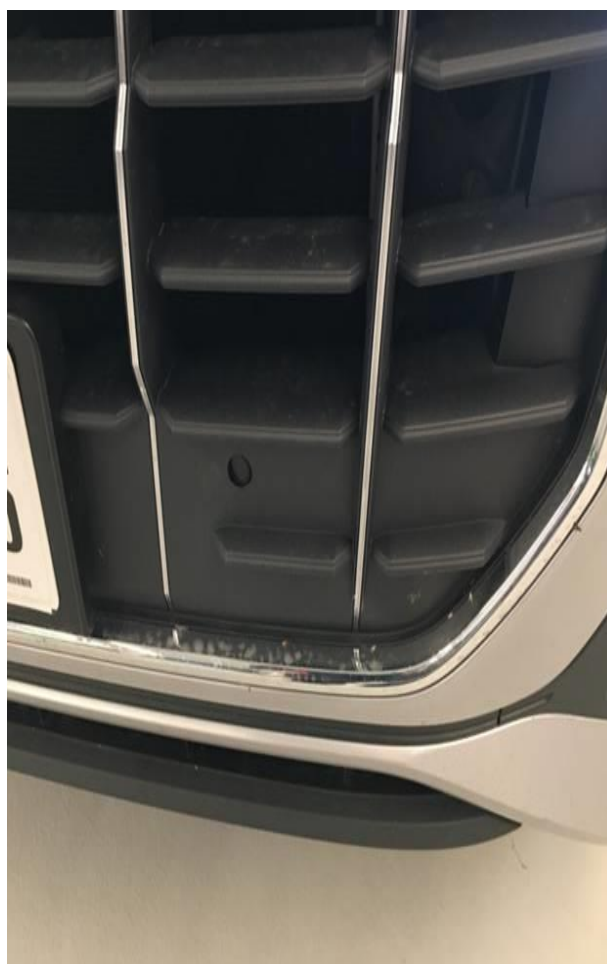
- The parking assist intermittently alerts them to an obstruction in spite of there being no object in front of the vehicle.
- They may also state that one or more of the park assist sensors in the front grille appear to be 'pushed in' (Figure 1).

Figure 1. Park assistance sensor not properly fixed in position.

The electronic central electrical (BCM) control module, J519 (address word 0009) may have one or more DTCs stored that indicate a technical issue with either the front or rear park assistance system. The park assistance sensor holder is found to be de-bonded from the component to which it was attached (front bumper, rear bumper, front grille, etc.).

- In some cases a replacement sensor holder is available as well as a technical description for its reattachment to the component. In these cases repairs can proceed as directed in the repair manual.

- In cases where the sensor holder is not available separately, then replace the entire component.
- In these cases be sure to retain the park assistance sensor holder(s) that have come loose.

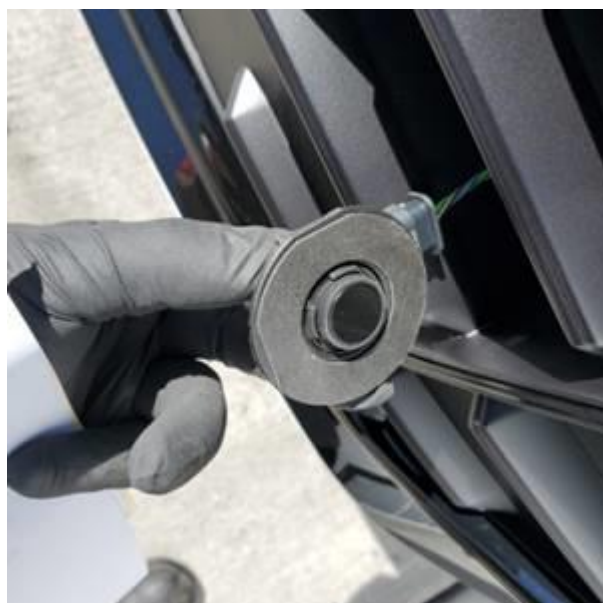
Figure 2. Park assistance sensor holder de-bonded from a front grille.

- The park assistance sensor holder(s) will be required to accompany the component from which it has de-bonded when the component is requested by the WPRC for part submission (Figures 2 and 3).

- Attach the sensor holder(s) to the component securely marking the position from which they were mounted.

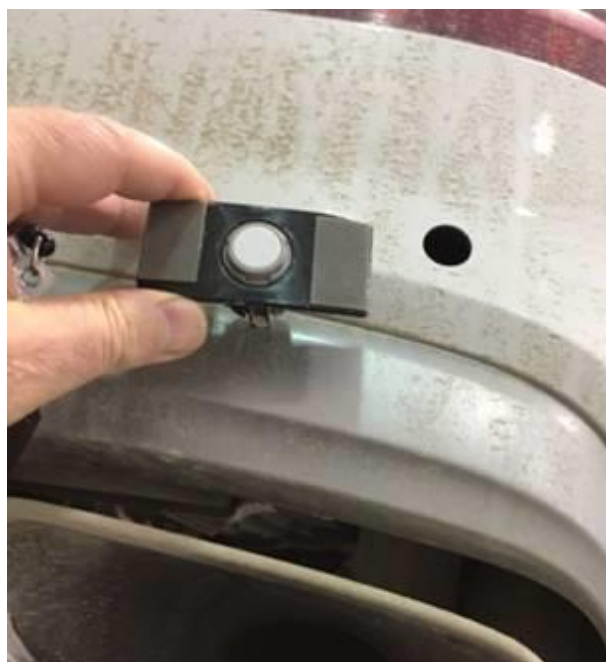
Figure 3. Park assistance sensor de-bonded from a rear bumper cover.
