STAR ONLINE PUBLICATION

Case Number: S2008000119

Symptom/Vehicle Issue: Service Hybrid Electrical System Displayed. DTC's P0CF1, P1B71-00, Or B12B0-00 Set. Water Intrusion Of The XY291A Inline Connector

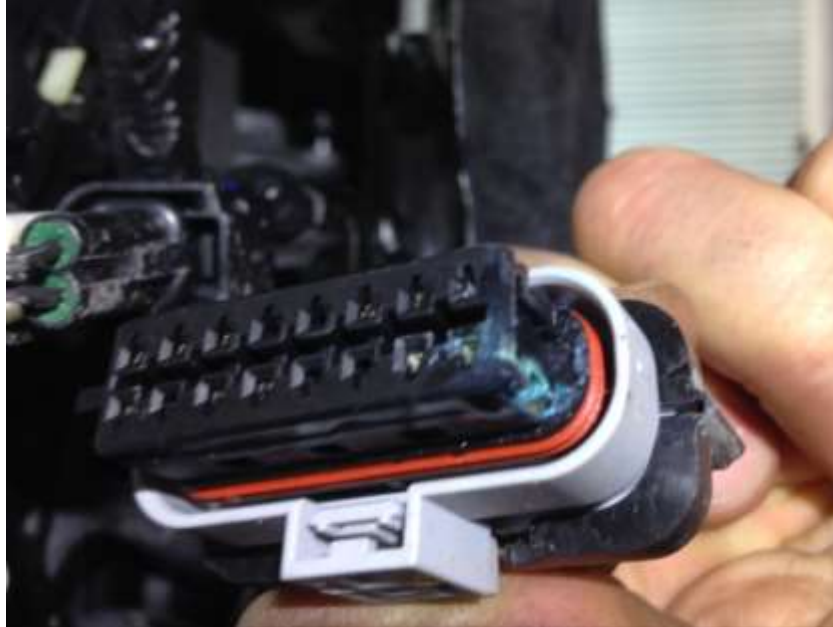
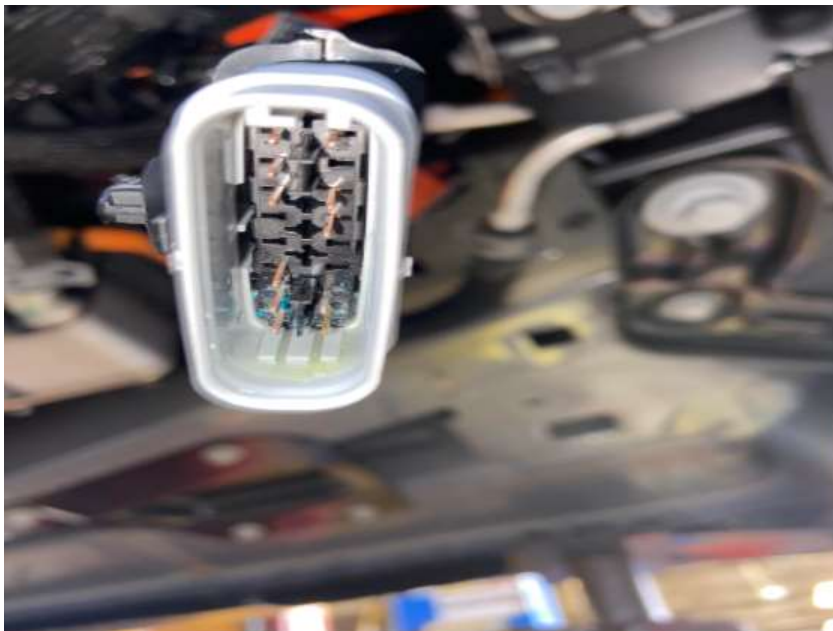
Corrosion Inside The XY291A Connector

Repair: If water or moisture is found inside the connector and but no damage is present, clean both female and male ends of the connectors and add dielectric grease. If corrosion or damage is found on the wiring terminals, replace both the dash and underbody wiring harnesses and fast track the original harness back to QEC.
