## STAR PUBLICATION

**Case Number:** S1908000143 – REV. A

**Symptom/Vehicle Issue:** Cluster Displays Multiple Warning Lamps, Intermittent IHS BUS Loss Of Communication, Front Wipers Swipe Once Intermittently Without Request

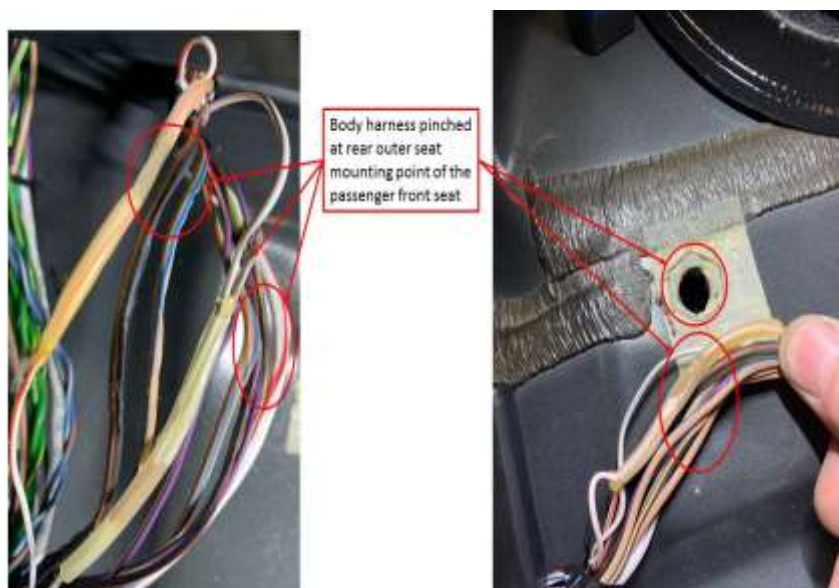
**Repair Procedure:** Inspect Body harness next to right B-Pillar for any pinched, chaffed, or damaged wires at rear outer seat mounting point of the passenger front seat or center floor harness routing around stow-n-go seating storage areas. It may be necessary to remove the front passenger seat and the stow-n-go access panels for the second row seats (reference service information as needed) to gain access to the harness routed within the areas described. Inspection and or wiggle test harness at splice location S910 IHS circuit D265.

If damage or corrosion is found at harness locations, clean, splice and repair per service information. After harness repairs, it is imperative to reroute and or isolate the harness from any contact areas. Test the operations of the involved systems as needed to complete. See images below Fig 1, 2, 3, 4.
