## STAR ONLINE PUBLICATION

**Case Number:** S2008000128

**Symptom/Vehicle Issue:** Hood Ajar Lamp On, ESS Inoperative, DTC P257E Engine Hood Switch Circuit Low

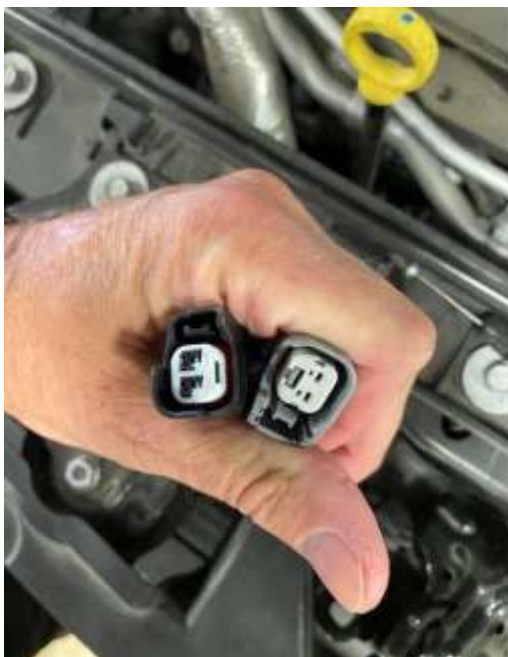
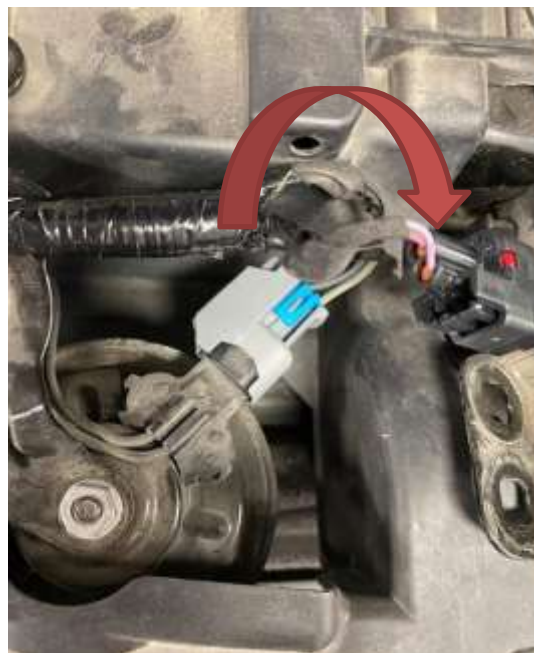
**Discussion:** Test the operation of the horn, if the horn does not function inspect the hood ajar connector and horn connector located at the latch assembly near the horn/hood latch. The two component connectors are similar in size and may be reversed during repairs. Re-connect the appropriate connector to the horn and ajar switch; test the operation to complete.
