STAR ONLINE PUBLICATION

Case Number: S2008000132

Symptom/Vehicle Issue: U11E9 Lost Communication With AGS (Active Grille Shutter), Malfunction Indicator Lamp (MIL) Illuminated

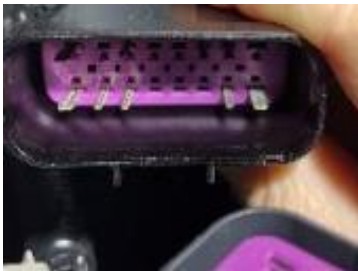
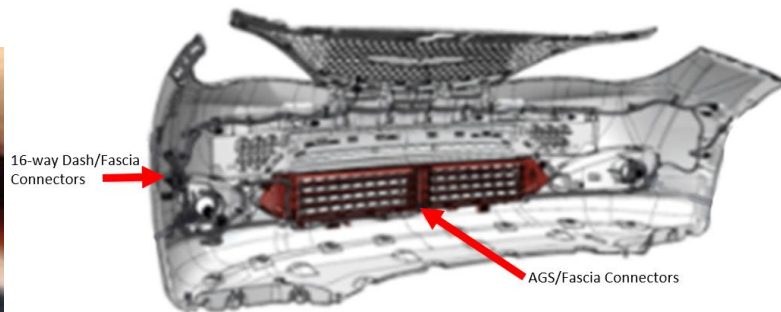
1. Inspect the wiring near the 16-way XY101A Dash to Fascia Connector for nicks and cuts. Also disconnect the connector and inspect for corrosion.

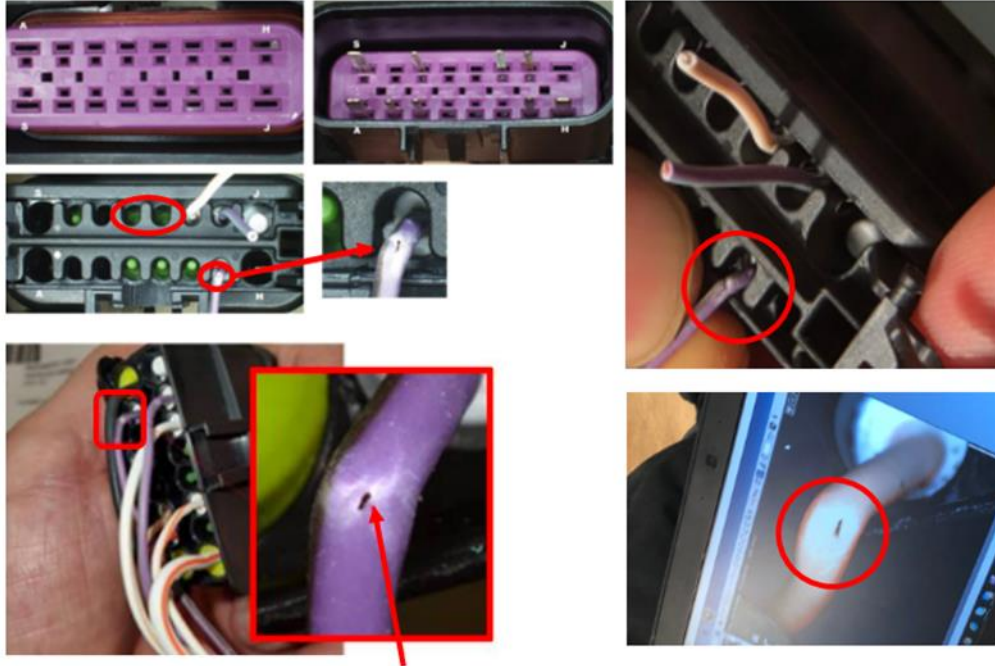
16-Way XY101A Inline Connector Damage

1. If corrosion or damage is present at the XY101A connector. Use connector kit 68497543AA to repair the 16-way dash side connector and replace the fascia side harness (a connector repair kit is not available).
2. If corrosion is present in the AGS connector, replace the AGS. Do not add dielectric grease to the AGS/fascia connectors. If corrosion is present in the fascia connector, repair it using connector kit 68396618AB or replace the harness as necessary.

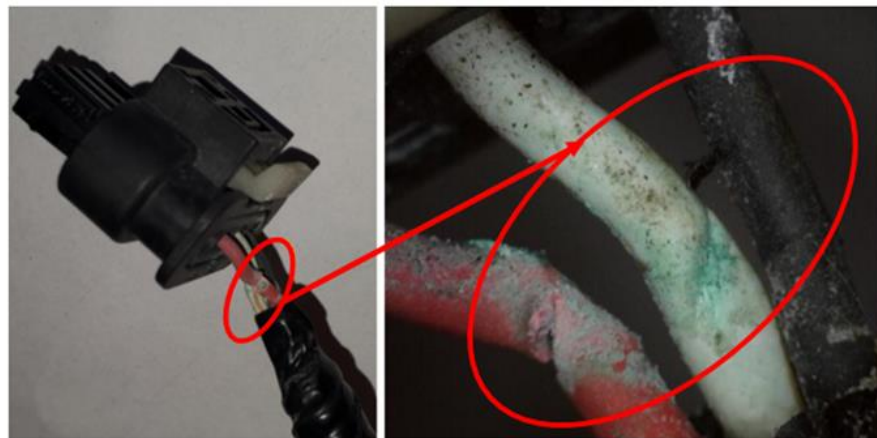
2. Disconnect the AGS to fascia connectors and inspect for damage and corrosion.

Active Grill Shutter Connection Damage/Corrosion
