NUMBER: 11-003-20

Drone, Pop, or Rattle Noise From The Passenger Side Floor Area

2020 (KL) Jeep Cherokee

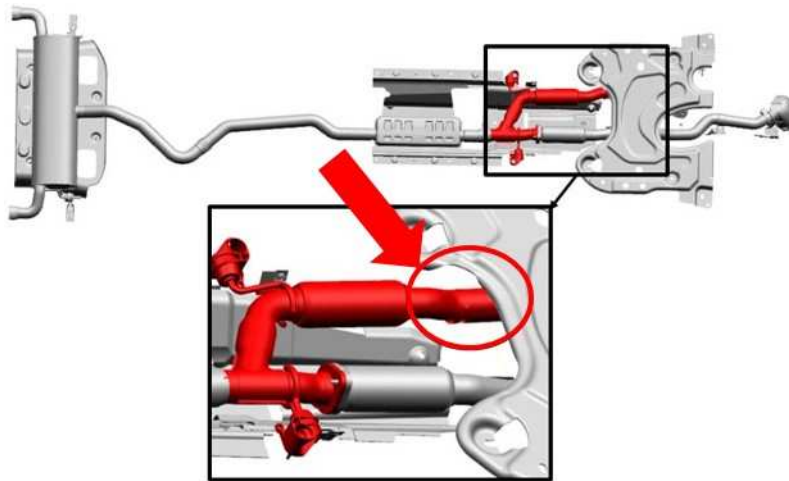
Fig. 1
Area To Measure

3. Inspect the passenger side under floor exhaust pipe in the area downstream of the catalytic converter flange but before the flex assembly. Measure the clearance between the exhaust and the steel skid plate ([Fig. 1](#)). The measurement should be **greater than 20 mm (0.78 in.)**.

4. Is the measurement between the exhaust and the steel skid plate **less than 20 mm (0.78 in.)**?
- YES >>> Replace the exhaust pipe assembly and gaskets. Proceed to [Step 1](#) of the Repair Procedure.
 - NO >>> This bulletin does not apply. Normal diagnosis should be performed.

1. Remove the belly pan. Refer to the detailed service procedures available in DealerConnect> Service Library under: Service Info>13 - Frame and Bumpers/Under Body Protection/Belly Pan/Removal.
2. Replace the exhaust pipe assembly and gaskets. Refer to the detailed service procedures available in DealerConnect> Service Library under: Service Info> 11 - Exhaust System/Pipe, Exhaust/Removal/Installation.
3. Install the belly pan. Refer to the detailed service procedures available in DealerConnect> Service Library under: Service Info>13 - Frame and Bumpers/Under Body Protection/Belly Pan/Installation.
4. Lower the vehicle.
