NUMBER: 23-018-20 REV. C

DATE: August 26, 2020

Active Head Restraint (AHR) Inadvertent Deployment - X88 Warranty Extension

**2014 - 2018	(WK)	Jeep Grand Cherokee **
2014 - **2018**	(WD)	Dodge Durango

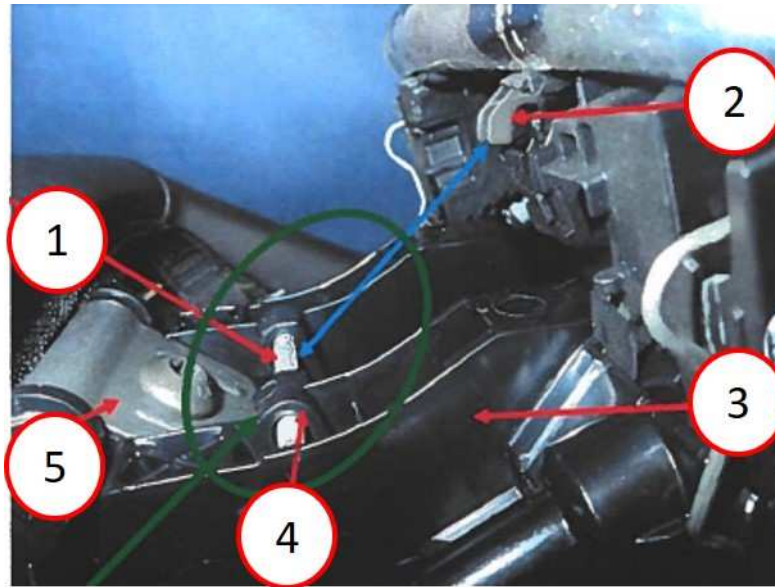
Fig. 1

1. Verify the sled bracket striker pin is attached to the sled bracket (Fig. 1) and (Fig. 2) .

Normal Deployed Position - AHR Can Be Reset

- 1 - Striker Pin Correctly Attached To The Sled Bracket
 - 2 - Latch Pawls
 - 3 - Sled
 - 4 - Sled Bracket With Pin Attached
 - 5 - Tilt Clip
-

- YES >>> This bulletin has been completed, use inspection LOP (23-20-48-98) to close the bulletin.
- NO >>> The striker pin is locked in the AHR latch (Fig. 2) . Proceed to Step 1 of the Repair Procedure.

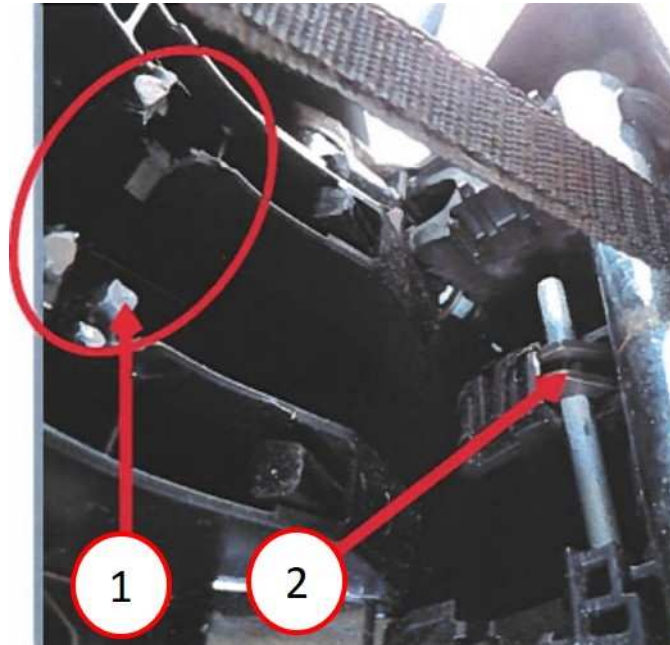
Fig. 2

Deployed AHR Has Failed And Will Not Reset

- 1 - Sled Bracket Failed
 - 2 - Striker Pin Fastened/Locked To Latch (**Will Not Reset**)
-

1. Replace the AHR. Refer to the detailed procedures available in DealerCONNECT > Service Library> under: 23 - Body/Seats/Headrest, Front/Removal/Installation.
