Service Bulletin

Bulletin No.: 16-NA-205

Subject: Blu-Ray Movies Do Not Start After Play Icon Selected on Menu

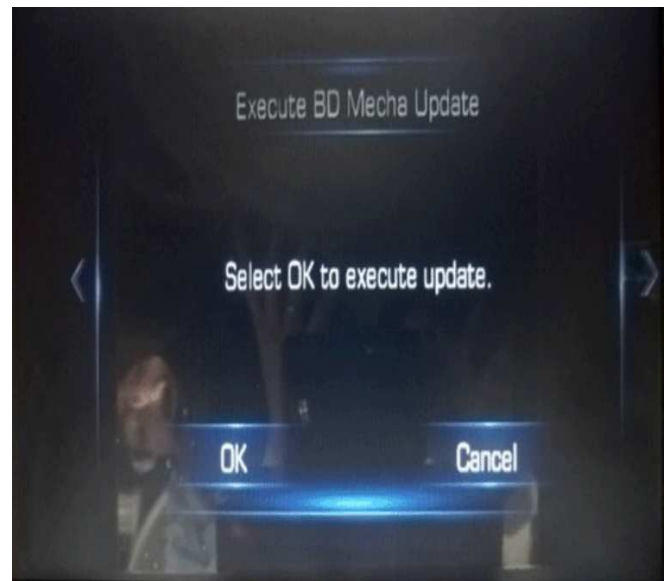
4560467

Remove any media in the Media Disk Player and insert the update disk in the Media Disk Player, which is located in the instrument panel or in the glove box. Once the Update Disc has been inserted, the popup shown above will appear on the rear display(s).

Select OK by highlighting the button with the remote control and hitting enter. After a short time, the Update Disc will automatically eject. REMOVE the disk.

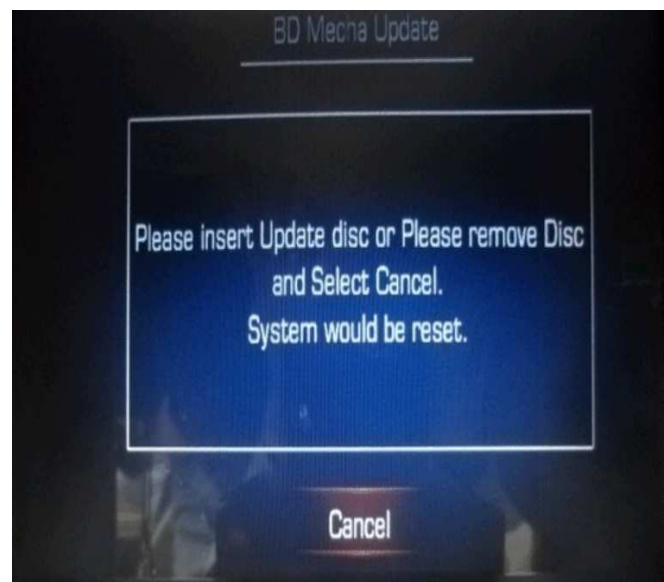
4560468

The following screen will be shown on the rear display(s). Re-insert the same Update Disc. Do **NOT** select “Cancel.”

WAIT for the files to be copied. Do NOT turn the power off. Do NOT touch the system until the disk ejects automatically in about 20 minutes. Once the disk ejects remove the disk. After the disk has been removed, the update process will continue for a couple more minutes.

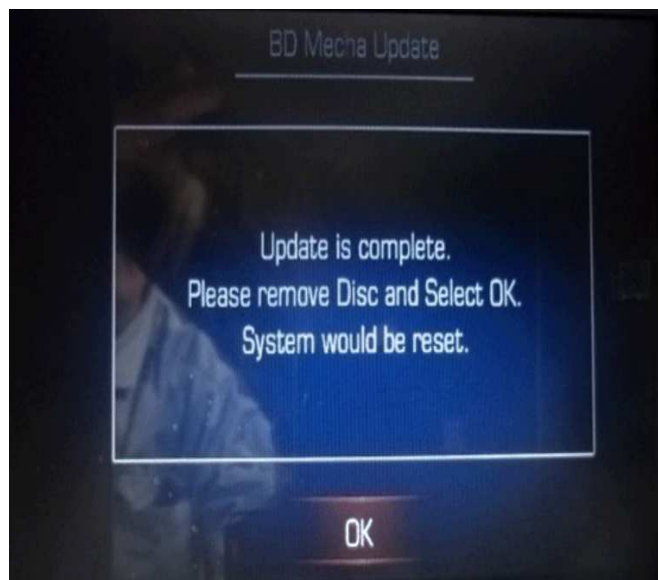
4560469

When the update process has finished, the message shown above will appear on the rear display(s).

Select OK with the remote control by pressing enter and the Media Disk Player will restart automatically.

After the Media Disk Player restarts, press the menu button on the remote control, select software information, and then select version. In the "Other Micros" section, verify that B/E = 06/01/16 and F/E = 03/12/14.
