# Service Bulletin

Bulletin No.: 18-NA-054

**Subject: Momentary Sharp Deceleration During 1-2 Upshift or a Momentary Neutral During 2-4 Upshift, Transmission Stuck in 2nd Gear (fluid below 32°F), Malfunction Indicator Lamp (MIL) Illuminated - DTC P2820 and/or P2821 Set During Cold Ambient Temperatures**

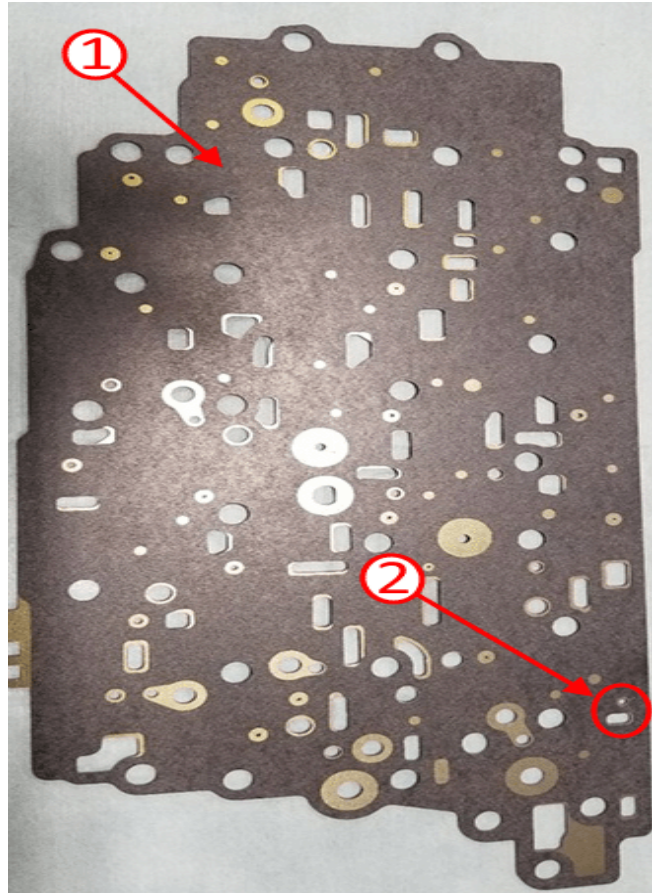
4885522

This condition may be caused by the spacer plate (1), located between the valve body and the transmission case, containing an undersized orifice (2).

⇒ The consequence is the clutch select moves slowly to release the selectable one way clutch, which causes a momentary transmission tie up during the 1-2 upshift.
