# Service Bulletin

Bulletin No.: 18-NA-383

**Subject: Water Found in Rear Interior of Cab, Water Leak at Rear Sliding Window**

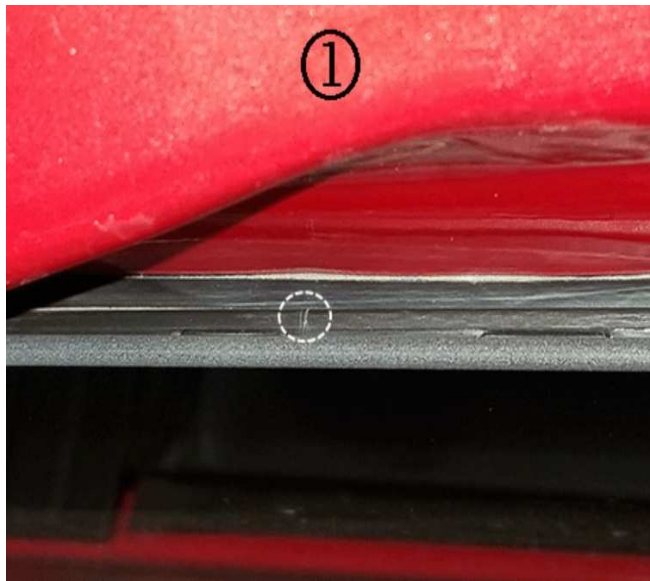
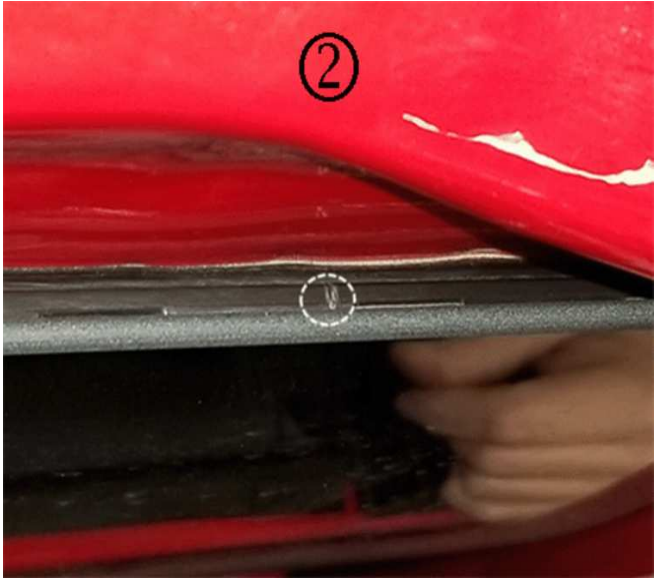
<p style="text-align: right;">5201855</p> <p><b>Note:</b> The cracks can be in the left and/or right side of the rear sliding window plastic upper rail glass guide which is covered by the roof rear spoiler. Examples of a left (1), then right side (2) visual crack (with the spoiler removed) are shown in the graphics above.</p> <p>The cause of the condition may be cracking in the rear sliding window plastic upper rail glass guide. The plastic upper rail glass guide may develop small fractures/cracking which allows water to pass through on the glass side of the urethane that attaches to the vehicle body.</p>
<p><b>Correction</b></p>	<p><b>Important:</b> When verifying this condition, ensure that the water leak path is due to cracks in the rear sliding window plastic upper rail glass guide, and NOT a leak in the primary urethane seal, between the window and the body; or from the spoiler attachments to the truck cab which are in the same area. Please indicate power sliding rear window crack in warranty claim verbiage.</p> <p><b>A leak in the primary urethane seal should be addressed by removing and resealing the window, using the standard service procedure from SI.</b></p> <p>R &amp; R the roof rear spoiler and apply seam sealer to the rear sliding window top encapsulate, following the steps in the Service Procedure below.</p> <p><b>Note:</b> If the vehicle underwent this bulletin repair, was released to the customer and later returned for the same concern, replace the rear sliding window assembly. Refer to <i>Rear Window Replacement</i> in SI, AND ensure that during application of the urethane to the new window, that the urethane covers the complete length of the top encapsulation of the window.</p>
