# Service Bulletin

Bulletin No.: 19-NA-008

**Subject:** Upper Inboard Corner of the Rear Body Structure Stop Lamp Has Sharp Edge

Brand:	Model:	Model Year:		VIN:		Engine:	Transmission:
		from	to	from	to		
GMC	Acadia (VIN N)	2017	2019			All	All
	Terrain	2018	2021

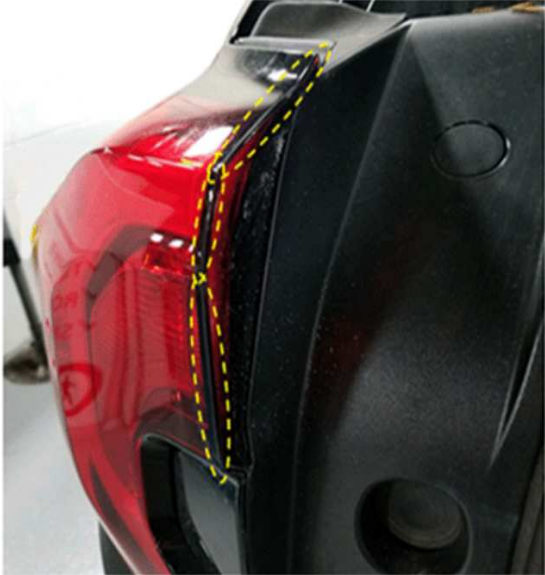
<p style="text-align: right;">5217579</p> <p><b>Terrain Rear Body Structure Stop Lamp</b></p> <p>Customer may comment on noticing, or feeling, a sharp edge on the upper, inboard corner of one, or both, of the rear body structure stop lamps.</p>
<p><b>Cause</b></p>	<p>The cause of the condition may be excess flashing created during the rear body structure stop lamp production process.</p>
<p><b>Correction</b></p>	<p><b>Important:</b> DO NOT replace the lamp for this sharp edge condition.</p> <p>Raise the rear liftgate and inspect both stop lamps for excess material (flash) at the parting line on the existing lamp, at the location shown above.</p>
