# Service Bulletin

Bulletin No.: 19-NA-226  
Date: August, 2020

**Subject:** Launch Control Inoperative

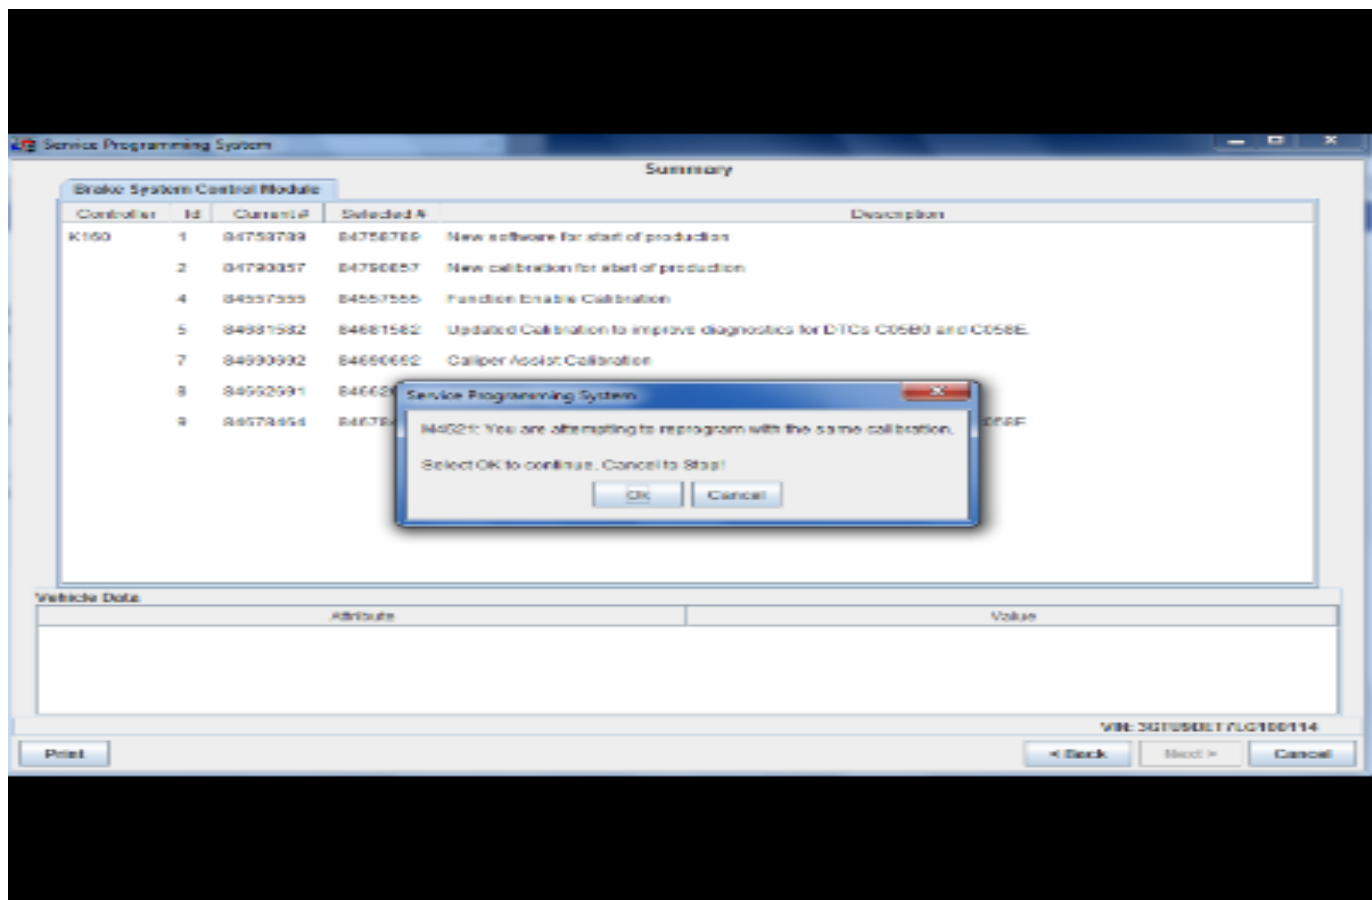
5431207

**Important:** TIS2WEB screen shown. Techline Connect screen is similar and will be included soon.

**Important:** If the Same Calibration/Software Warning is noted on the SPS screen, select OK and follow screen instructions. After a successful programming event, the WCC is located in the Service Programming

System dialogue box of the SPS Summary screen. No further action is required. Refer to the Warranty Information section of this bulletin.
