# Service Bulletin

Bulletin No.: 20-NA-129  
Date: August, 2020

**Subject:** Rear View Camera Display Bright At Night

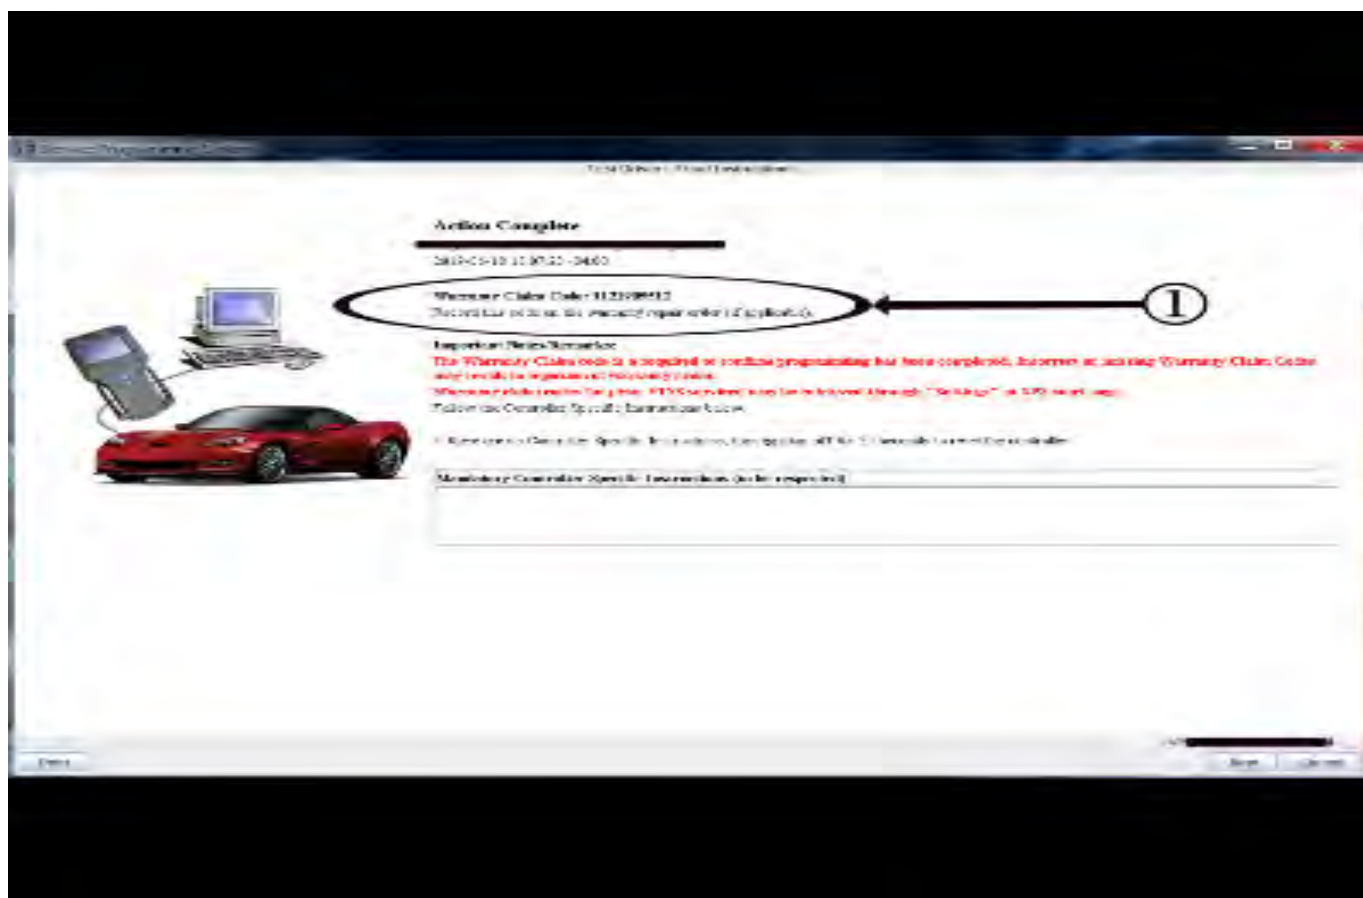
5431209

**Important:** To avoid warranty transaction rejections, you **MUST** record the warranty claim code provided on the SPS Warranty Claim Code (WCC) screen on the job card. Refer to callout 1 above for the location of the WCC on the SPS screen

2. Record SPS Warranty Claim Code on job card for warranty transaction submission.
