Service Bulletin

Bulletin No.: 20-NA-154

Subject: Flutter or Boom Noise Around 1100 RPM

Brand:	Model:	Model Year:		VIN:		Engine:	Transmission:
		from	to	from	to	Eligilie.	Transmission.
Buick	Encore GX (VIN M)	2020	2020	_	_	1.3L (L3T)	All

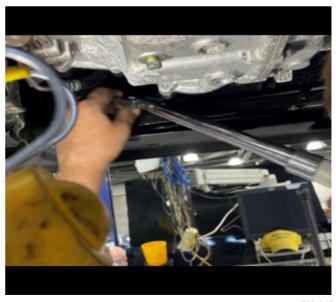
5634945

Involved Region or Country	North America	
Condition	Some customers may comment that during low speed driving, with light throttle input, a booming noise and/or vibration is felt through the vehicle.	
Cause	The cause of the condition may be the lower radiator mount bushings.	
Correction	If you encounter a vehicle with the above conditions, review the Service Procedure outlined below.

4. Replace the lower radiator mounts.

Note: Be sure to tighten the fasteners to $22\,N^{\circ}m$ (16

lb ft).
