Service Bulletin

Bulletin No.: 20-NA-162

Subject: Information on Excessive Amounts of Dirt and Debris on Fuel Cap

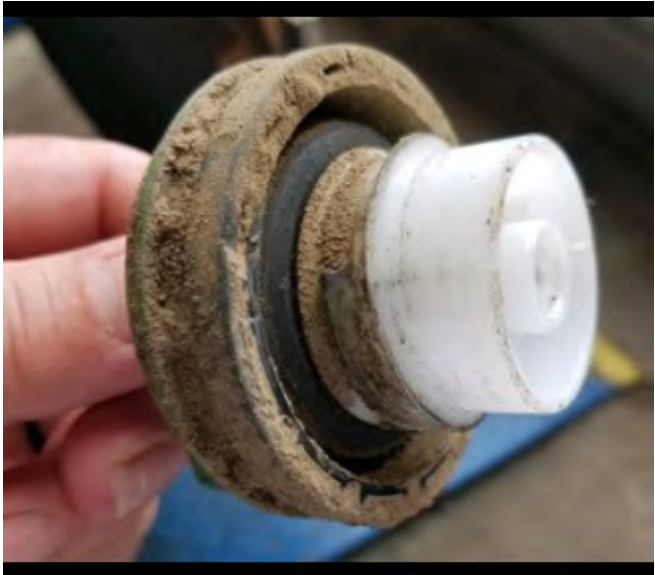
<div>5641096</div> <p>Some customers may comment that excessive amounts of dirt and debris is building up on the fuel cap.</p>	
Cause	Important: This repair is a customer pay alteration. All work and payment, authorization must come from the customer.

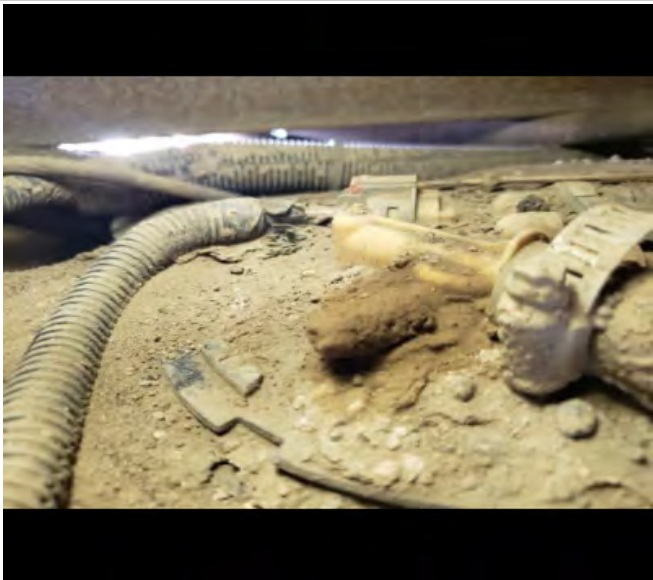
5641708

This condition may be caused by excessive build up of dirt and debris on the fuel tank vent.

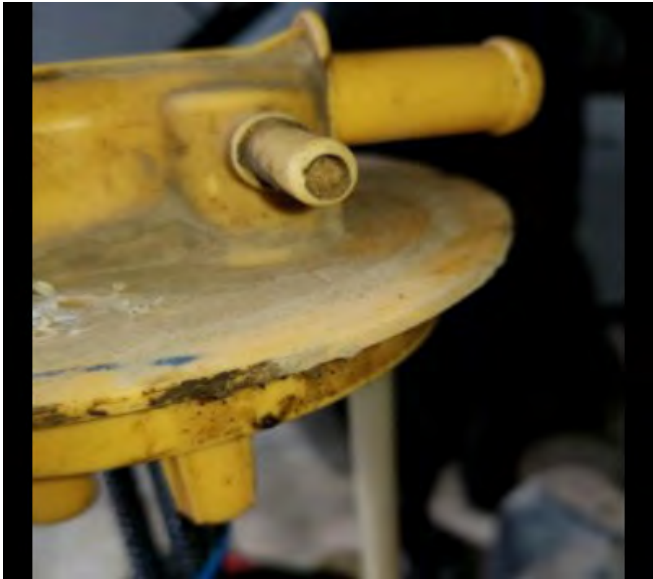
5641101

– Over time, this will plug and the venting of the tank will be through the fuel cap.
