# Service Bulletin

Bulletin No.: 20-NA-163

**Subject:** Rearview Camera Displaying Narrow Guidelines and Zoomed Out/Fisheye Appearance

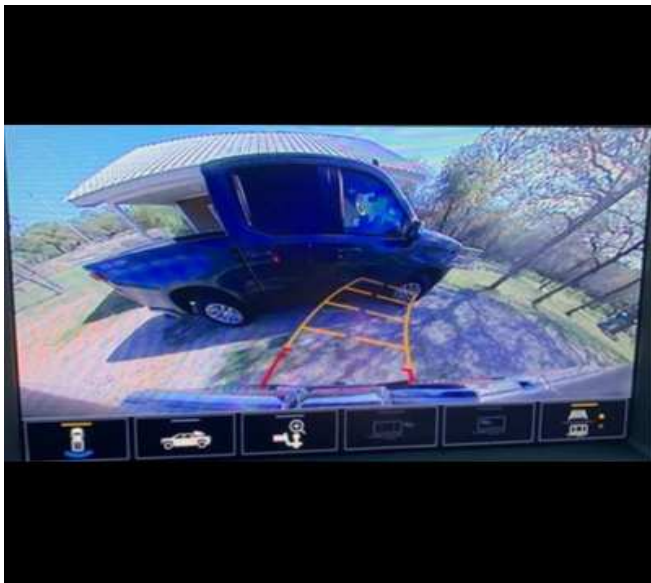
| <b>Condition</b> | <p>Some customers may comment on narrow guidelines and a zoomed out/fisheye appearance from the rearview camera.</p> <p>5642270</p> |
| <b>Cause</b> | The cause of the condition may be an issue with the Video Processing Control Module (VPCM) calibration distorting the view from the rearview camera and decreasing the width of the guidelines. |

| <b>Correction</b> | Reprogram the VPCM. Follow Service Procedure below. |
