Service Bulletin

Bulletin No.: 20-NA-164

Subject: Wire Brushing Type Noise Heard from Brake Rotors

Brand:	Model:	Model Year:		Breakpoint:		Engine:	Transmission:
		from	to	from	to		
Cadillac	CT6	2019	2020	—	—	Equipped with 2.0L or 4.2L Engine (RPOs LSY, LTA)	—

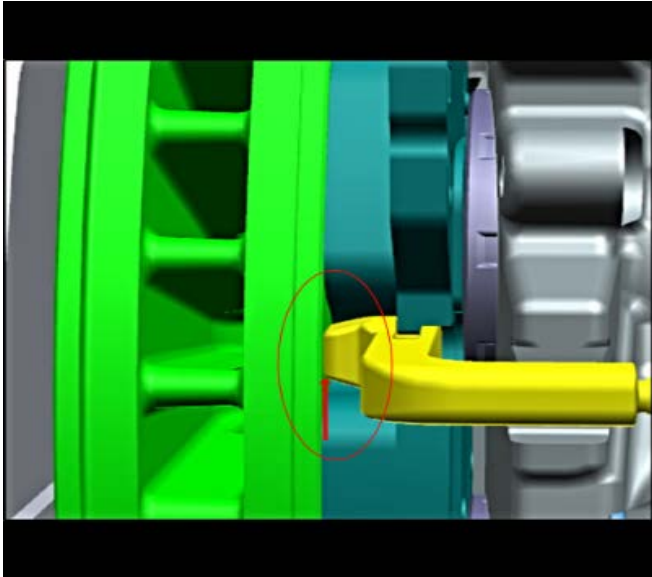
Involved Region or Country	United States, Canada, Europe, Russia, Middle East, Israel, Japan, Cadillac Korea (South Korea)
Additional Options (RPOs)	Equipped with BRAKE SYSTEM-HEAVY DUTY / BRAKE SYSTEM-POWER, FRT & RR DISC, ABS, 19", HEAVY DUTY (RPOs J55, J6H)
Condition	Some customers may comment on a wire brushing type noise heard from the brake rotors.
Cause	<div style="text-align: right; margin-bottom: 5px;">5543923</div>

<p>This condition may be caused by the brake pad wear sensor being loose and making contact with the brake rotor, as shown in the picture above.</p>
Correction	Add adhesive to the slot of the brake pad wear sensor at the interface of the brake pad following the Service Procedure listed below.
