# TECHNICAL SERVICE BULLETIN

## Engine Will Not Turn Off And/Or Various Electrical Symptoms - BJB Cover Not Fully Seated

**20-2298**  
01 September  
2020

**Ford**  
2020 F-Super Duty

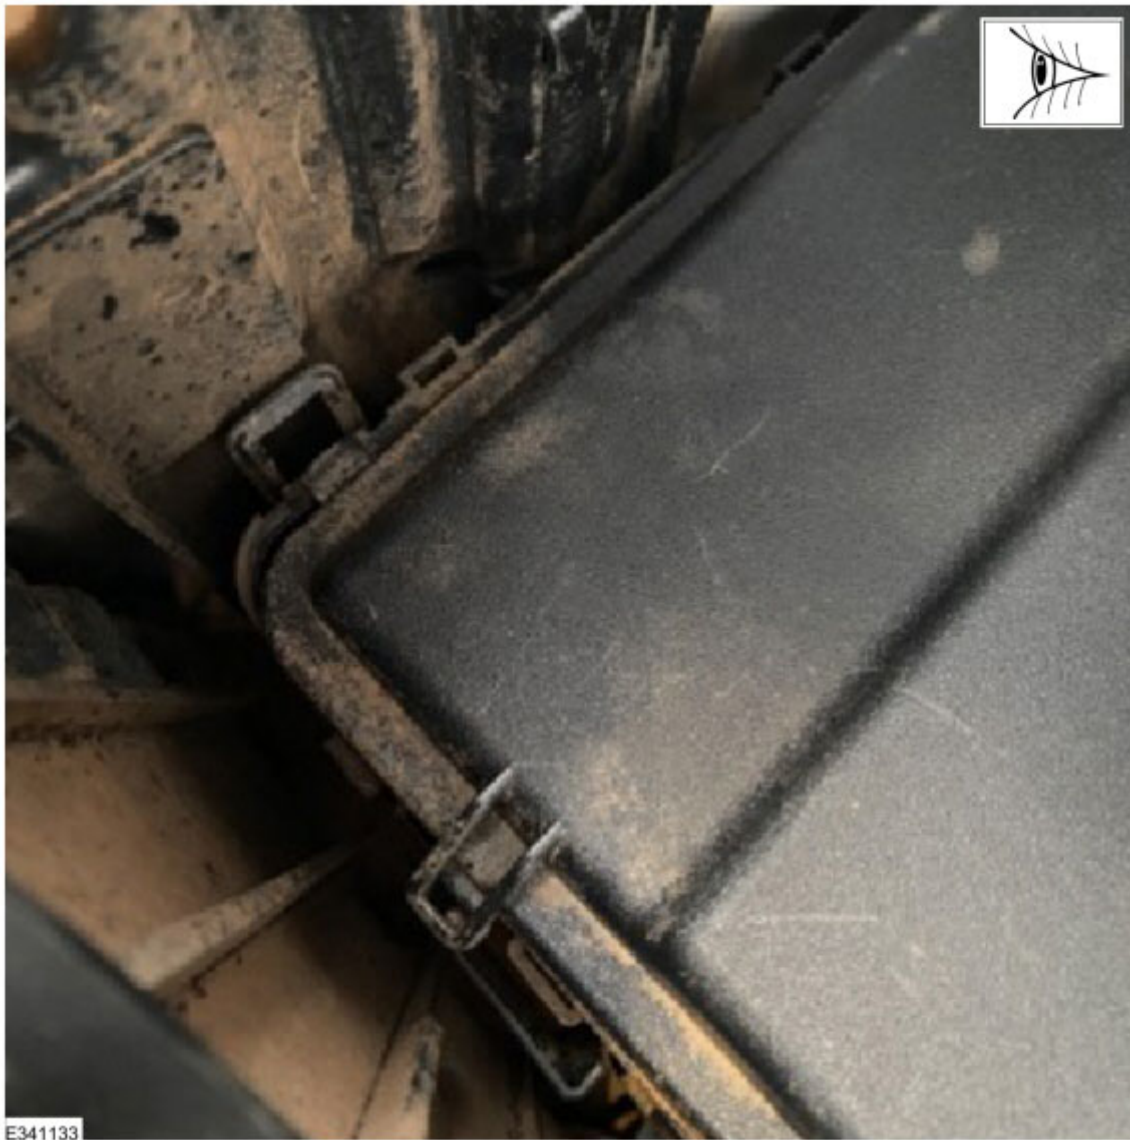
1. Visually inspect the BJB for signs of water/moisture intrusion. Are there signs of water/moisture intrusion into the BJB and/or broken cover tabs/locking fingers?

Figure 1 - Example of moisture intrusion with BJB cover on

## 2. Replace the BJB assembly.

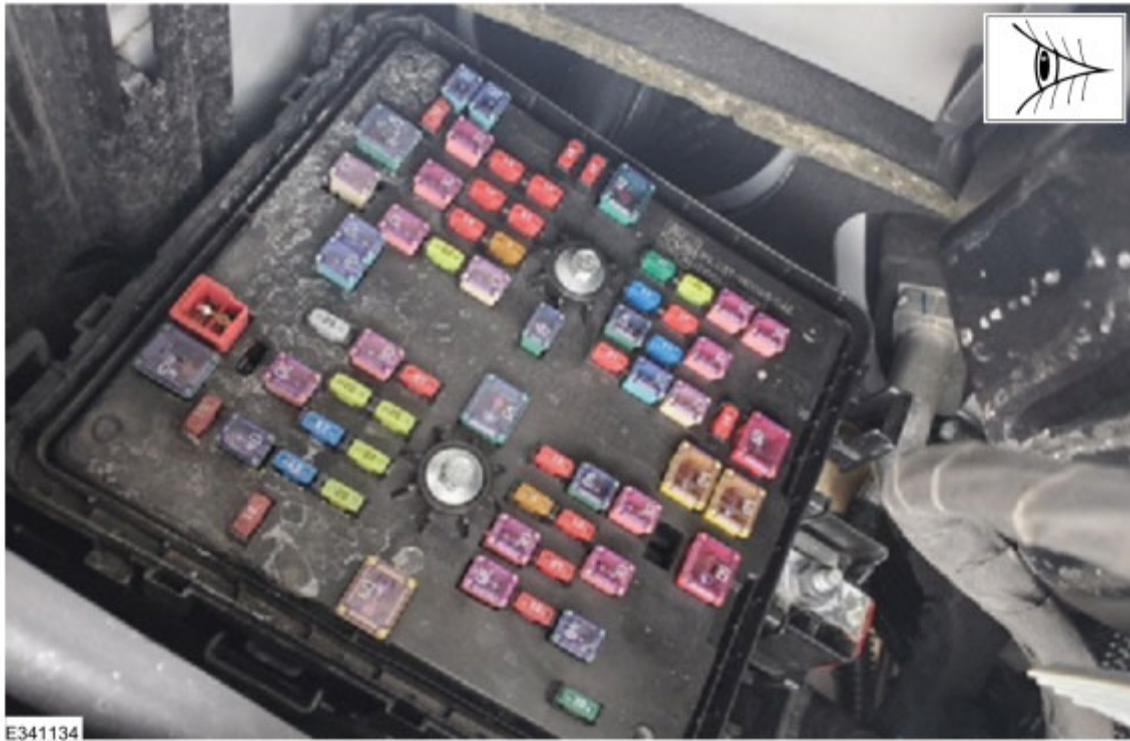
Figure 2 - Example of moisture intrusion with BJB cover off

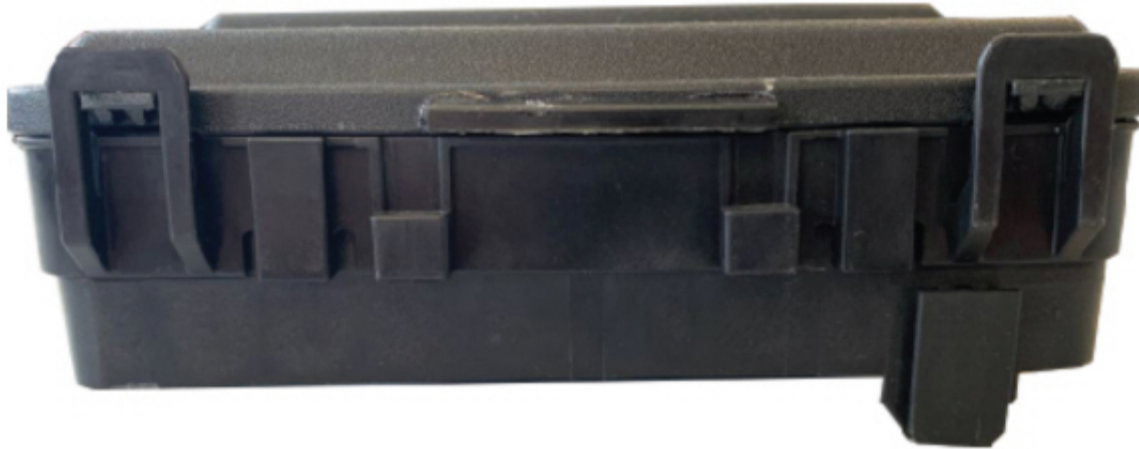
E341135

Figure 3 - Correct cover installation

- (9). Install the new BJB cover making sure the cover tabs/locking fingers are installed correctly.
- (10). Install the battery tray and battery back into the vehicle. Refer to WSM, Section 414-01.

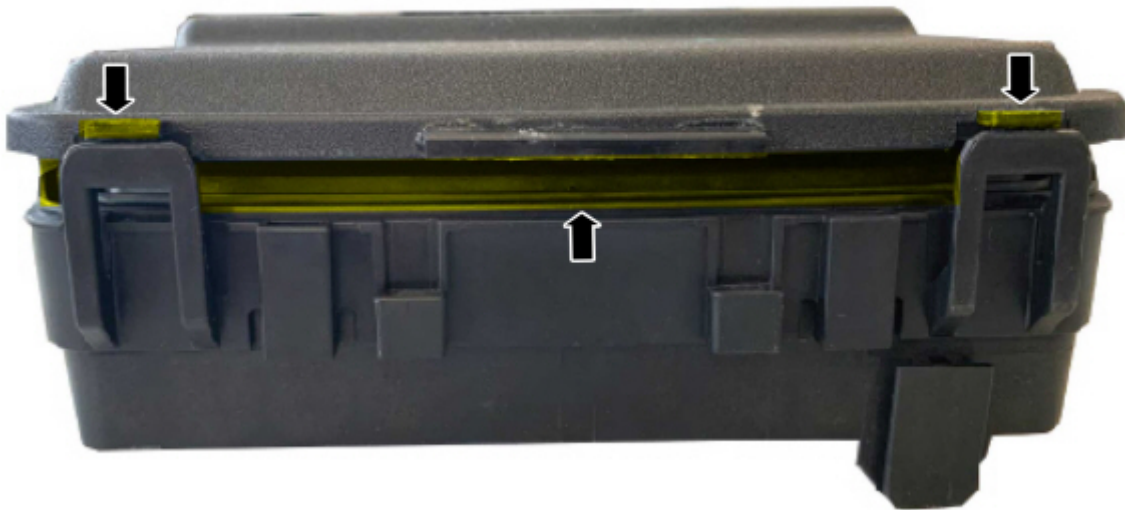
E341136

Figure 4 - Incorrect cover installation

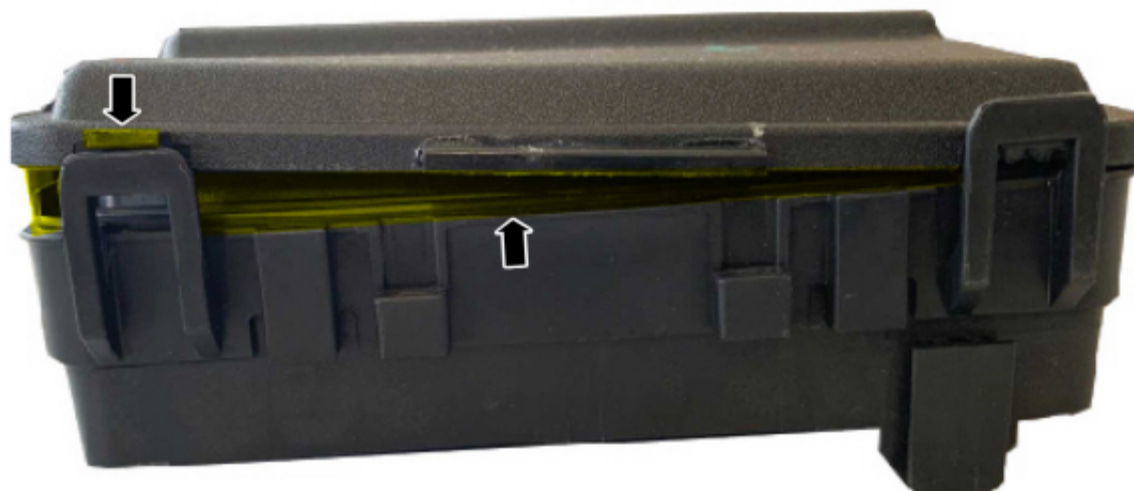
E341137

Figure 5 - Incorrect cover installation

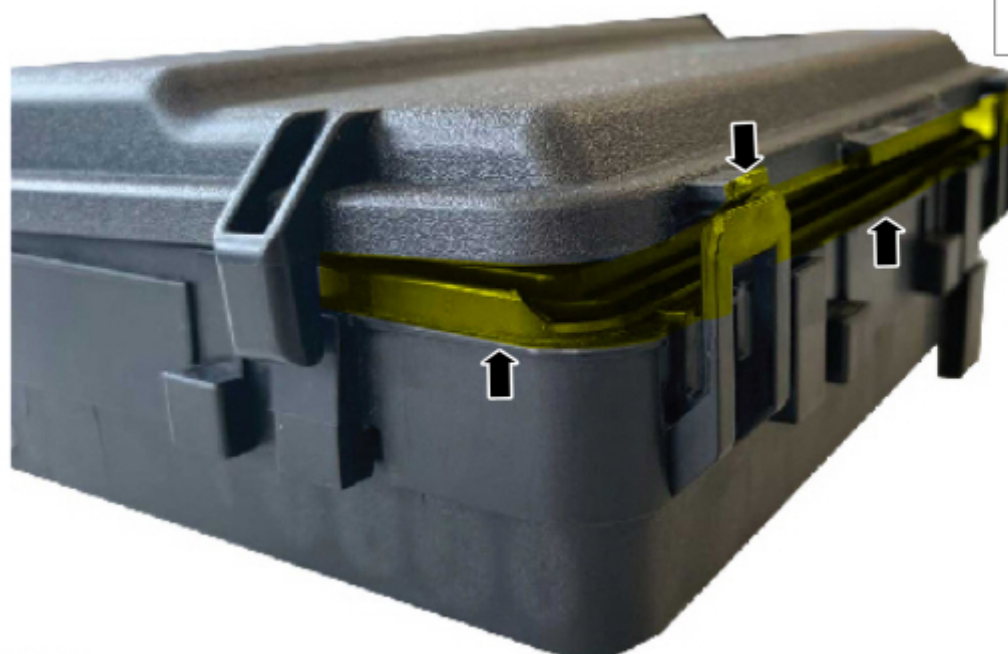
E341138

Figure 6 - Incorrect cover installation
