TECHNICAL SERVICE BULLETIN

Infotainment Screen Concerns, Wi-Fi Connection Message, Rear View Camera Operation, CarPlay And/Or Voice Prompt Concerns

**20-
2301**
08
September
2020

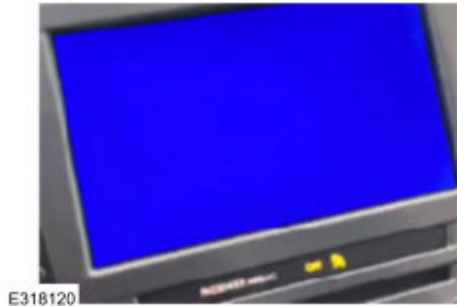
Figure 1

- Solid blue screen when moving forward at speeds above 16 km/h (10 mph) (Figure 1)
 - The rear parking aid camera remains on the screen at speeds below 16 km/h (10 mph) (Figure 2)

This may be due to the SYNC Software. To correct the condition, follow the Service Procedure to update the accessory protocol interface module (APIM) software.

1. Disconnect all customer connected USB items from all media hub locations.
2. Start the vehicle.
3. Insert the SYNC 3 universal thumb drive into the USB port on the media hub.
4. The module automatically updates with no user input required.
 - (1). Modules already at the latest software level will indicate this after approximately 30 seconds.
 - (2). Module programming for a non-updated module does not need to be monitored and can take approximately 20-30 minutes.
 - (3). Once the reprogramming has completed, the screen will display a message indicating the module is up to date.
5. Remove the SYNC 3 universal thumb drive when complete. The screen returns to the SYNC 3 home screen. Reconnect any of the customer USB items. No vehicle or system restarts are required.
