Mack Chassis - Rear Drive, Transverse Torque Rod Bracket Failure

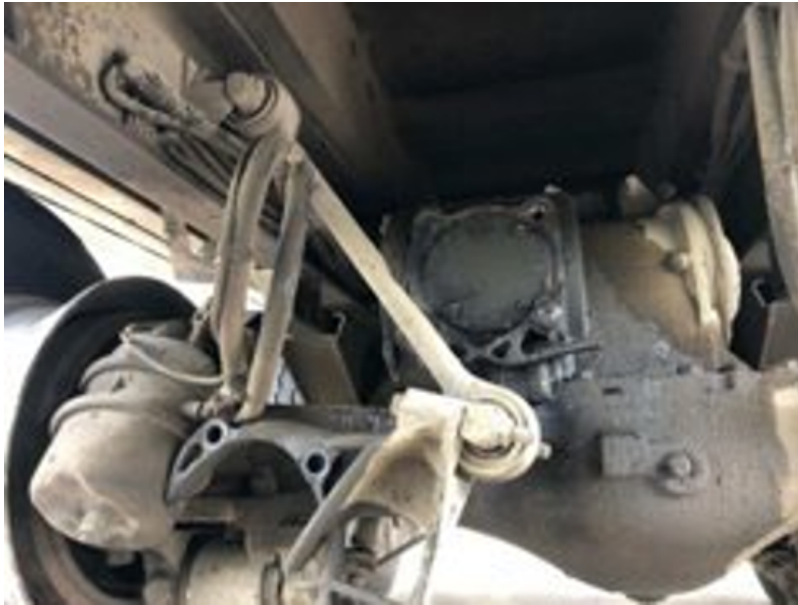
Mack Trucks has seen an increase in Mack rear drive, transverse torque rod bracket failures.

Failures happen after the studs loosen on the rear of the carrier or when the bracket does not sit flat on the carrier housing to the torque rod bracket.

Inspect for a raised boss area on the carrier
Inspect for bracket not being seated flush with the carrier housing
Remove studs
If applicable grind smooth to match the flat surface for the bracket (be careful to grind smooth so no cracks form)
Clean and install the studs with Loctite 263. Torque to 225-275 lb-ft.
