**P1C9500 Faults Causing “Transmission failure – Park vehicle safely” warning in Instrument Cluster**

**Vehicles Affected**

Models	Model Year	Model Type	VIN Range	Vehicle-Specific Equipment
Taycan	2020	Y1ADB1, Y1AFC1, Y1AFH1	N/A	N/A

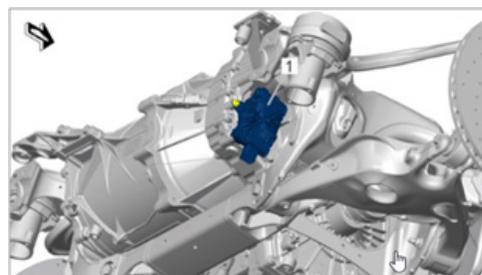
**Figure 1 - ETSM (1)  
Location on Transmission**

The presence of **DME Faults P1C9500 – “Actuator (clutches) - deactivated with data trouble codes 009DF9 and 00A6FA**, resulting in the instrument cluster warning **“Transmission Failure – Park Vehicle Safely.”** Other diagnostic trouble codes are associated with fault P1C9500, therefore it is important to verify the existence of the two aforementioned codes.

An initialization issue in the control unit for the servomotor causing this fault is resolved in a pending VR software release.

1. Switch off ignition
2. Pull electric plug from the electronic transmission servo motor (ETSM) -> ETSM is marked blue in Figure 1
3. Please wait 60 seconds
4. Put electric plug back on the ETSM
5. Turn ignition on
6. Please wait 60 seconds
7. Switch off ignition
8. Repeat Step 5-7
9. Clear fault memory
