P1C9500 Faults causing the Instrument Cluster Warning “Transmission failure – Park vehicle safely” and Immobility

Models	Model Year	Model Type	VIN Range	Vehicle-Specific Equipment
Taycan	2020	Y1ADB1, Y1AFC1, Y1AFH1	N/A	N/A

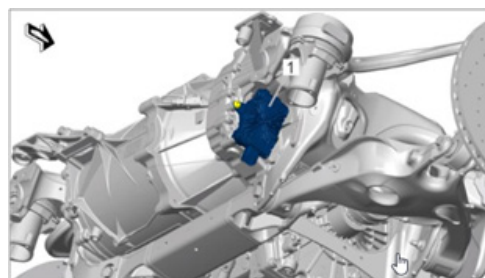
**Figure 1 - ETSM (1)
Location on Transmission**

The presence of **DME Faults P1C9500 – “Actuator (clutches) - deactivated with data trouble codes 009DF9 and 00A6FA**, resulting in the instrument cluster warning **“Transmission Failure – Park Vehicle Safely.”** Other diagnostic trouble codes are associated with fault P1C9500, therefore it is important to verify the existence of the two aforementioned codes.

An initialization issue in the control unit for the servomotor causing this fault is resolved in a pending VR software release.

1. Switch off ignition
2. Pull electric plug from the electronic transmission servo motor (ETSM) -> ETSM is marked blue in Figure 1
3. Please wait 60 seconds
4. Put electric plug back on the ETSM
5. Turn ignition on
6. Please wait 60 seconds
7. Switch off ignition
8. Repeat Step 5-7
9. Clear fault memory
