Emissions Recall

Code: 26N6

Subject	Catalyst																		
Release Date	September 24, 2020																		
REVISION SUMMARY	Updated claiming instructions, part information and work instructions with latest catalyst information.																		
Affected Vehicles

Subject: Emissions Recall 26N6 - Catalyst

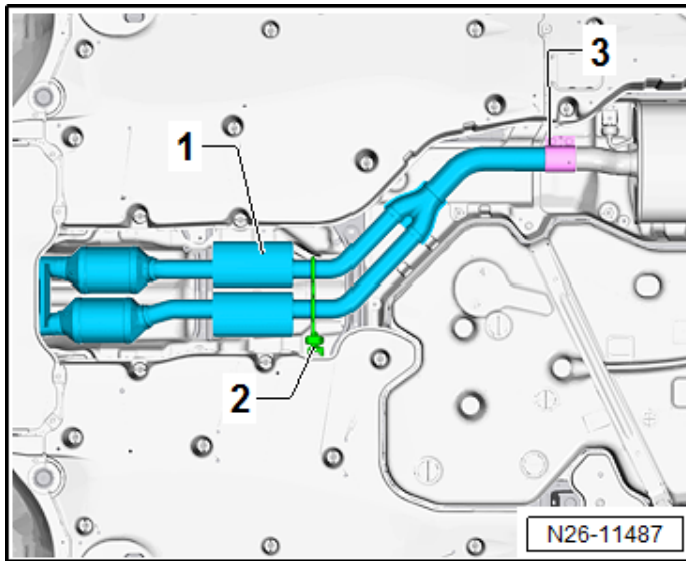
Repair Overview

What is the issue? Over time and mileage, the factory-installed catalyst may not perform as required. If the effectiveness of the catalyst is reduced, this may result in increased tailpipe emissions and the vehicle could fail an emissions (IM) inspection.

- Replace catalyst and update ECM software.
