101/20 ENU 9152

Complaint - PCM Update Cannot be Performed/Stops. Observe Specified Procedure (101/20)

Model Line: Taycan (Y1A)

Subject: Porsche Communication Management (PCM 6.0) central computer

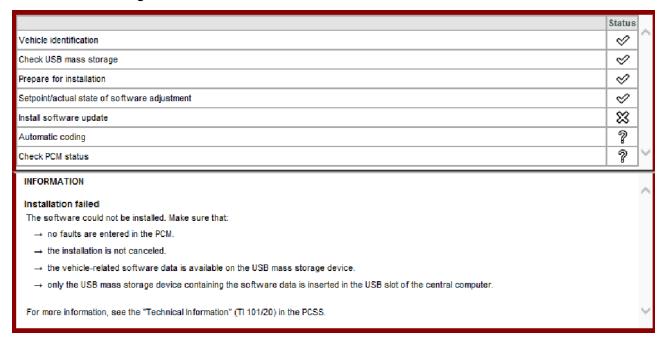
Information: There is a possibility that a central computer (PCM) software update via USB storage medium

is not performed successfully and an error message is displayed on the PIWIS Tester \Rightarrow *Error*

Error message on PIWIS Tester

Observe the procedure described under 'Work Procedure' to avoid having to replace the central

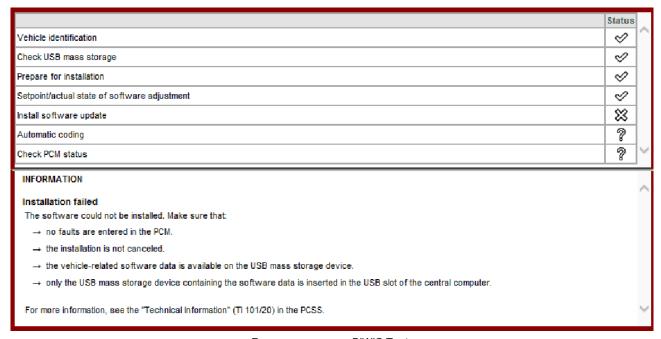
Error message on PIWIS Tester

If control unit programming stops and an error message is displayed on the PIWIS Tester \Rightarrow *Error message on PIWIS Tester*, proceed as follows:

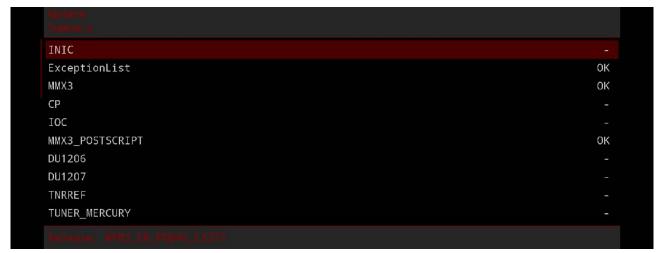
Overview of modules

- 1 Check the PCM central display to see whether all modules were installed ⇒ Overview of modules -OK- or whether one or more modules are marked with the status NOK (Not OK).
 - If all modules are installed \Rightarrow Overview of modules -OK-, continue with Step $5 \Rightarrow$.
 - If one or more modules are marked with NOK or if an error message is displayed \Rightarrow *Error module*, continue with Step 2 \Rightarrow .

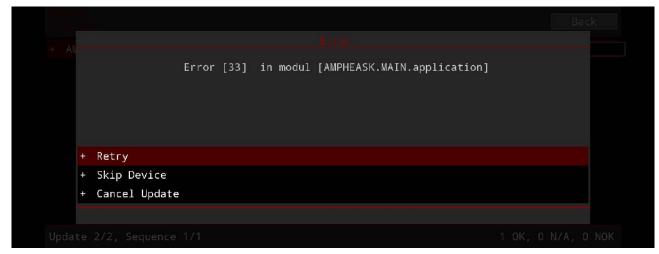
Error module

2 Click on 'Retry' in the 'Error' module ⇒ Error module. Carry out the procedure several times if necessary if the update continues and then stops again.

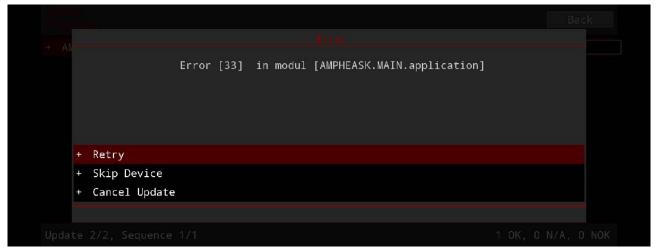
Error module

- If programming is still not performed, remove and re-insert the USB storage medium and carry out the procedure several times if necessary if the update continues and then stops again.
- 4 Subsequent procedure:
 - If the update is installed successfully, continue with Step $5 \Rightarrow$.
 - If the update is not installed successfully or if the central computer (PCM) no longer starts, contact your importer's Technical Support team to decide how to proceed.
- 5 Select the 'PCM (central computer)' control unit on the PIWIS Tester and select the 'Automatic coding' function in the 'Coding/programming' menu.
 - Once coding has been completed successfully, read out and delete the fault memory.
