# Emissions Recall

## Code: 26M4

<b>Subject</b>	Catalyst															
<b>Release Date</b>	September 24, 2020															
<b>REVISION SUMMARY</b>	<b>Updated claiming instructions, part information and work instructions with latest catalyst information.</b>															
<b>Affected Vehicles</b>

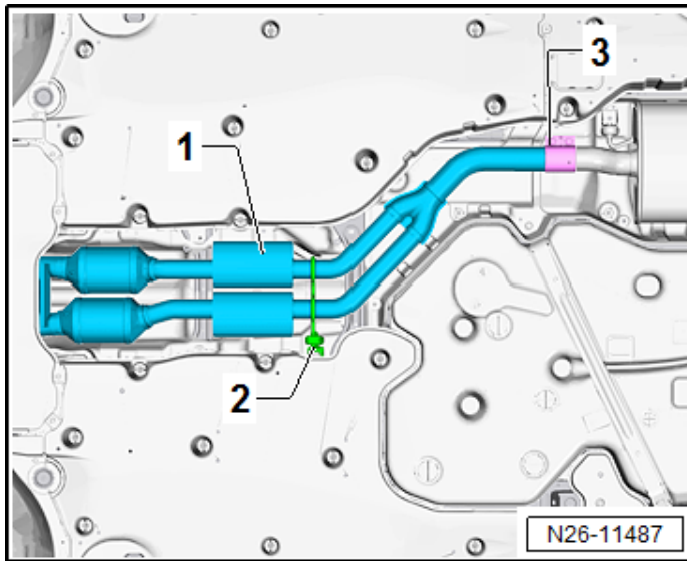
- Replace catalyst and update ECM software.
