**Complaint - Oil Leaks on Double Clutch Transmission (Porsche Doppelkupplung (PDK)):
Observe Specified Procedure (88/20)**

Model Line: **911 Carrera (992)**

Subject: **Double clutch transmission (PDK)**

Information: Oil leaks on double clutch transmission.

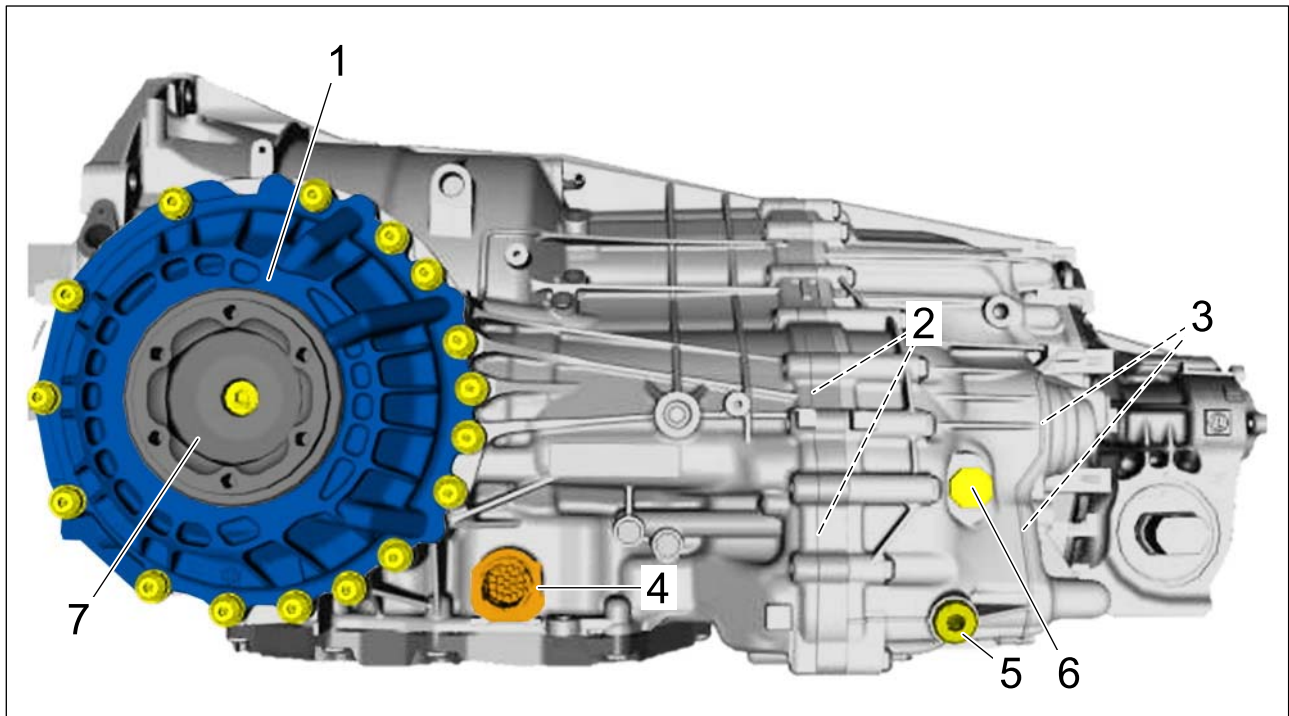
Right side of transmission

Position	Leak area	Possible cause(s)	Repair measure
⇒ Right side of transmission-1-	Differential cover 1A - 1C	Sealing ring damaged (A)	Replace sealing ring, see ⇒ <i>Workshop Manual '391555 Replacing flanged-shaft sealing ring'.</i>
		Screw loose (B)	Replace screws, see ⇒ <i>Workshop Manual '391555 Replacing flanged-shaft sealing ring'.</i>
		O-ring damaged (C)	Replace O-ring, see ⇒ <i>Workshop Manual '391555 Replacing flanged-shaft sealing ring'.</i>
⇒ Right side of transmission-2-	Rear transmission housing seal 2A - 2B	Screw loose (A)	Replace double clutch transmission, see ⇒ <i>Workshop Manual '373419 Removing and installing double clutch transmission'.</i>
		Seal damaged (B)	
⇒ Right side of transmission-3-	Front transmission housing seal 3A - 3B	Screw loose (A)	Replace double clutch transmission, see ⇒ <i>Workshop Manual '373419 Removing and installing double clutch transmission'.</i>
		Seal damaged (B)

⇒ Right side of transmission-4-	Central connector at the left 4A - 4B	Sealing ring damaged (A)	Replace wire harness, see ⇒ <i>Workshop Manual '387719 Removing and installing transmission control mechanism'.</i> Tighten screws to 3 Nm (2 ftlb.).
		Connector leaking (B)	
⇒ Right side of transmission-5-	Screw plug	Sealing ring damaged	Replace screw and tighten to 27 Nm (20 ftlb.). Re-use spring and sleeve during installation.
⇒ Right side of transmission-6-	Oil filler screw	Sealing ring damaged	Replace screw and tighten to 27 Nm (20 ftlb.).
⇒ Right side of transmission-7-	Right halfshaft flange 7A - 7C	Sealing ring damaged (A)	Replace sealing ring, see ⇒ <i>Workshop Manual '392255 Workshop Manual '392255 Replacing sealing ring for right halfshaft flange - double clutch transmission'.</i>
		Right halfshaft flange damaged (B)	Replace halfshaft flange, see ⇒ <i>Workshop Manual '392519 Workshop Manual '392519 Removing and installing right halfshaft flange - double clutch transmission'.</i>

Screw loose, leaking (C)	Replace screw, see ⇒ <i>Workshop Manual '392519 Workshop Manual '392519 Removing and installing right halfshaft flange - double clutch transmission'.</i>
--	--	--------------------------	---

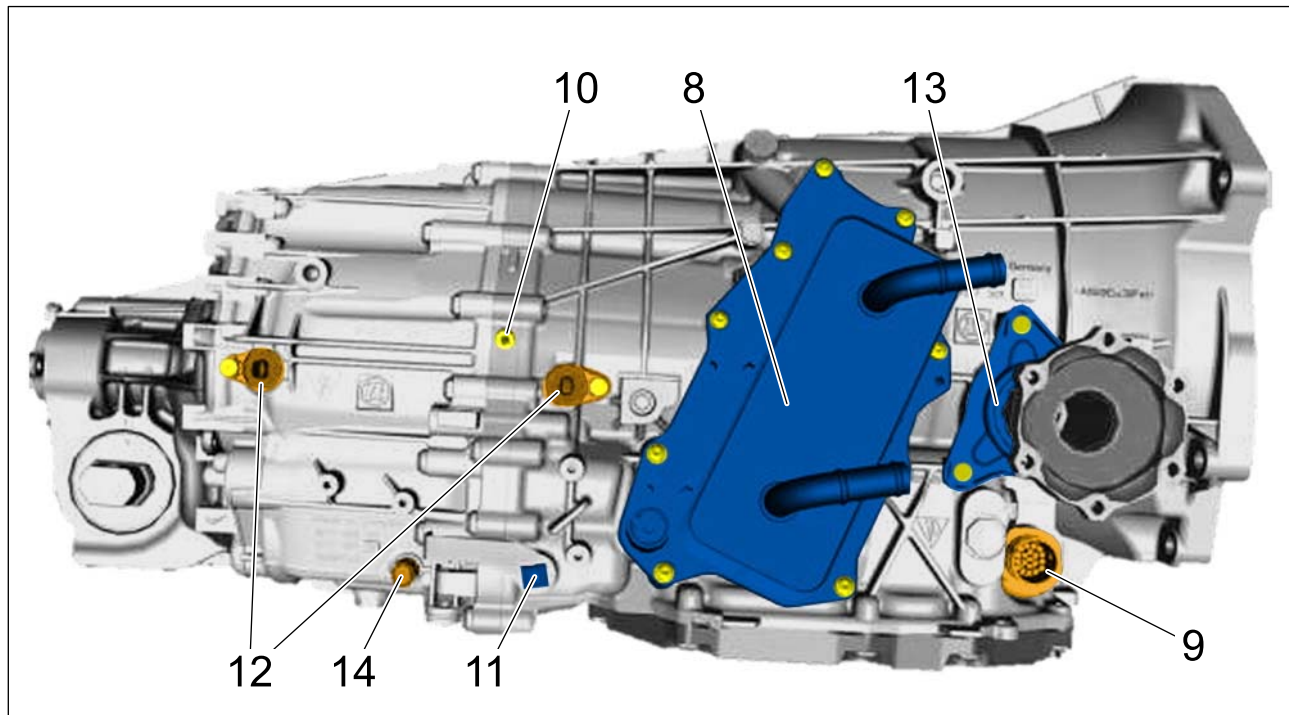
Position	Oil leak	Possible cause(s)	Repair measure
⇒ Left side of transmission (with ATF cooler) -8-	ATF cooler 8A - 8C	Screw loose (A)	Replace screw, see ⇒ <i>Workshop Manual '377219 Removing and installing transmission oil cooler'</i> .
	If there are oil leaks in the ATF cooler area, see also ⇒ Left side of transmission (without ATF cooler) -15 - 16-. ⇒ Left side of transmission (with ATF cooler) -8-	Seal damaged (B)	Replace seal, see ⇒ <i>Workshop Manual '377219 Removing and installing transmission oil cooler'</i> .
		ATF cooler leaking (C)	Replace ATF cooler, see ⇒ <i>Workshop Manual '377219 Removing and installing transmission oil cooler'</i> .
⇒ Left side of transmission (with ATF cooler) -9-	Central connector at the right 9A - 9B	Sealing ring damaged (A)	Replace double clutch transmission, see ⇒ <i>Workshop Manual '373419 Removing and installing double clutch transmission'</i> .
		Connector leaking (B)

⇒ Left side of transmission (with ATF cooler) -10-	Bleeder screw	Shaft sealing ring damaged	Replace double clutch transmission, see ⇒ Workshop Manual '373419 Removing and installing double clutch transmission'.
⇒ Left side of transmission (with ATF cooler) -11-	Selector shaft	Sealing ring damaged	Replace sealing ring, see ⇒ Workshop Manual '373355 Replacing selector shaft sealing ring'.
⇒ Left side of transmission (with ATF cooler) -12-	rpm sensor 12A - 12B	Sealing ring damaged (A)	Replace sealing ring.
		Screw loose (B)	Replace screw and tighten to 3.2 Nm (2.2 ftlb.) and a final tightening torque angle of 30°.
⇒ Left side of transmission (with ATF cooler) -13-	Left halfshaft flange	Grease leak on bearing	Replace bearing, see ⇒ Workshop Manual '392555 Replacing left halfshaft flange bearing'.
⇒ Left side of transmission (with ATF cooler) -14-	Temperature sensor 14A - 14B	Sealing ring damaged (A)	Replace temperature sensor, see ⇒ Workshop Manual '377419 Removing and installing transmission oil temperature sensor'.

Connector leaking (B)

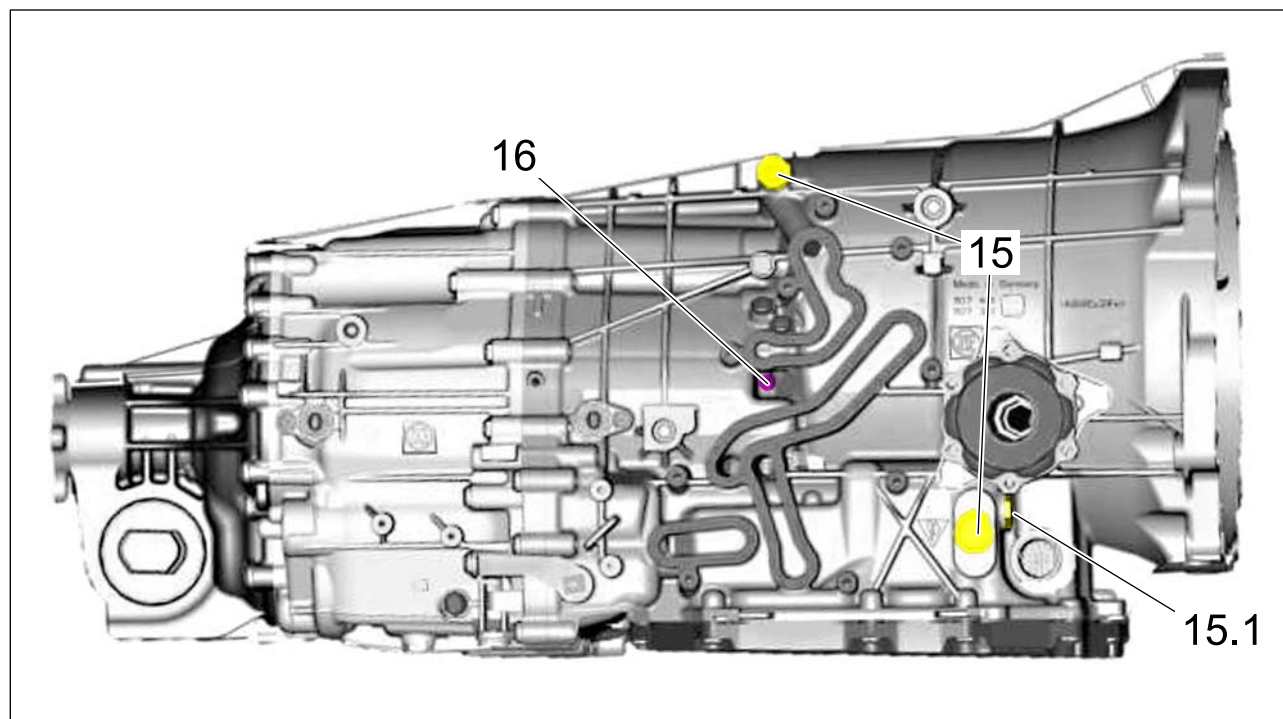
Position	Oil leak	Cause	Repair measure
⇒ Left side of transmission (without ATF cooler) -15-	Screw plug 15A - 15B	Screw loose (A) Sealing ring damaged (B)	Replace screw and tighten to 27 Nm (20 ftlb.). Replace screw, see ⇒ Workshop Manual '370235 Checking and topping up ATF'.
	Oil filler screw 15C - 15D	Screw loose (C) Sealing ring damaged (D)	
⇒ Left side of transmission (without ATF cooler) -15.1-	Screw plug 15.1A - 15.1B	Screw loose (A) Sealing ring damaged (B)	Replace screw and tighten to 27 Nm (20 ftlb.).
⇒ Left side of transmission (without ATF cooler) -16-	Oil chamber partition If there are oil leaks in this area, see also ⇒ Left side of transmission (with ATF cooler) -8- and ⇒ Left side of transmission (without ATF cooler) -15 / 15.1-.	Shaft sealing ring damaged	Check the area using an endoscope. Replace double clutch transmission if there are leaks, see ⇒ Workshop Manual '373419 Removing and installing double clutch transmission'.

If there is a leak around item 16, observe the specified procedure.

If the fault can be reproduced, the double clutch transmission must be replaced. If not, continue fault finding.

- Clean oil leak bore area and coat it directly with leak-locating spray
- Correct the oil level
- Perform a test drive
- Visually inspect the leak area of the oil leak bore

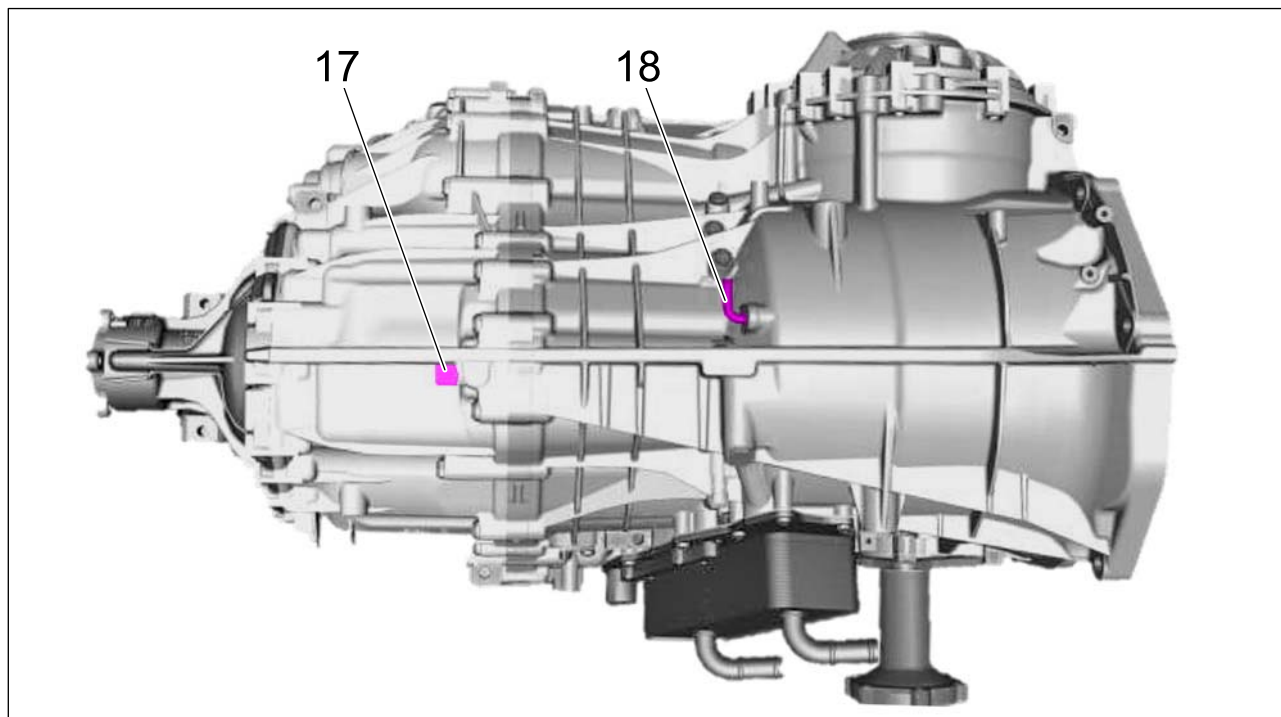
Position	Oil leak	Cause	Repair measure
⇒ Upper side of transmission -17-	Hydraulic chamber breather 17A - 17B	Oil over-filled (A)	Check oil level of hydraulic chamber and final drive, see ⇒ <i>Technical Information '373419 Concluding work'</i> . Oil level in hydraulic chamber too high and final drive OK: Correct the oil level. Oil level in hydraulic chamber clearly too high and final drive too low: Replace double clutch transmission, see ⇒ <i>Workshop Manual '373419 Removing and installing double clutch transmission'</i> .
		Insufficient defoamer (B)	Change ATF, see ⇒ <i>Workshop Manual '370255 Changing ATF'</i> .
⇒ Upper side of	Final drive breather	Oil over-filled	Check ATF and final drive oil level, see ⇒ <i>Technical Information '370255 Concluding work'</i> .

<i>trans- mission</i> -18-	Oil level in final drive too high and ATF OK: Correct the oil level. Oil level in final drive is clearly too high and ATF too low: Replace double clutch transmission, see ⇒ <i>Workshop Manual '373419 Removing and installing double clutch transmission'</i> .
--	--

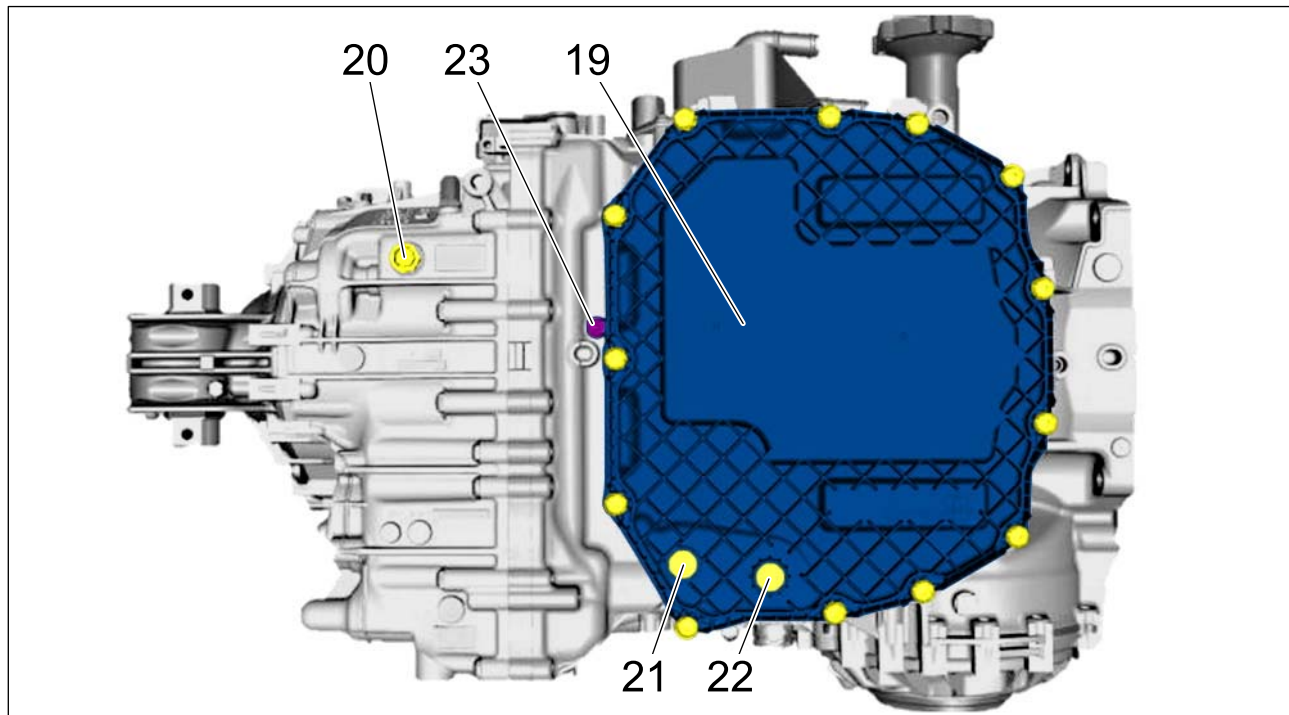
Position	Oil leak	Cause	Repair measure
⇒ Lower side of transmission -19-	ATF pan 19A - 19C	Screw loose (A)	Replace ATF pan, see ⇒ <i>Workshop Manual '375519 Removing and installing ATF pan'</i> .
		Seal damaged (B)	
		Traces of oil after opening the hydraulic chamber (C)	Clean the ATF pan.
⇒ Lower side of transmission -20-	Screw plug 20A - 20B	Screw loose (A)	Replace screw, see ⇒ <i>Workshop Manual '399035 Checking and topping up oil for final drive (PDK gear-wheel oil)'</i> .
		Sealing ring damaged (B)	
⇒ Lower side of transmission -21-	Screw plug 21A - 21B	Screw loose (A)	Replace screw, see ⇒ <i>Workshop Manual '370235 Checking and topping up ATF'</i> .
		Sealing ring damaged (B)

⇒ Lower side of transmission -22-	Oil drain plug 22A - 22B	Screw loose (A)	Replace screw, see ⇒ <i>Workshop Manual '370255 Changing ATF'</i> .
		Sealing ring damaged (B)	
⇒ Lower side of transmission -23-	Oil chamber partition	Shaft sealing ring damaged	Replace double clutch transmission, see ⇒ <i>Workshop Manual '373419 Removing and installing double clutch transmission'</i> .

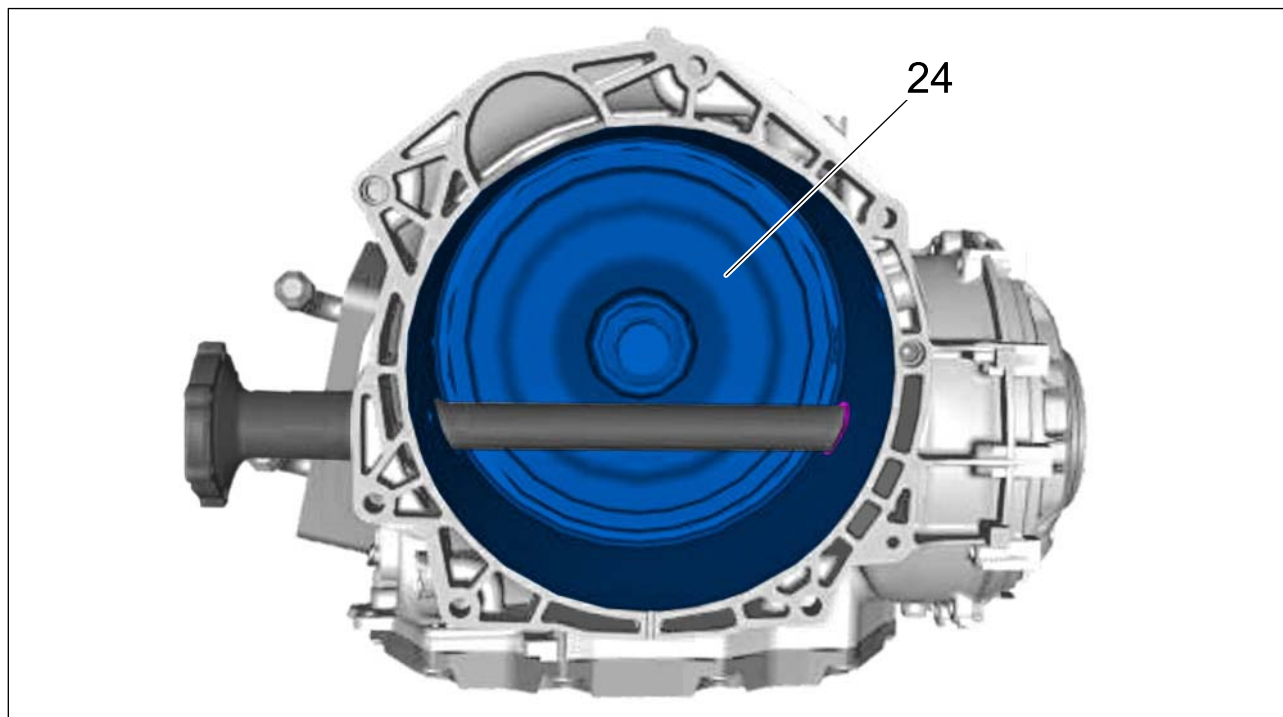
Position	Oil leak	Cause	Repair measure
⇒ Rear side of transmission -24-	Clutch bell-housing 24A - 24E	O-ring on clutch cover damaged (A)	Replace double clutch transmission, see ⇒ <i>Workshop Manual '373419 Removing and installing double clutch transmission'</i> .
		Intermediate shaft sealing ring damaged (B)	Replace sealing ring, see ⇒ <i>Workshop Manual '386955 Replacing radial shaft seal'</i> .
		Engine leaking (C)	Find oil leaks and fix them.
		Apparent preservative grease leak (D)	No action required.
		Flanged-shaft sealing ring damaged (E)	Replace sealing ring, see ⇒ <i>Workshop Manual '391555 Replacing flanged-shaft sealing ring'</i> .

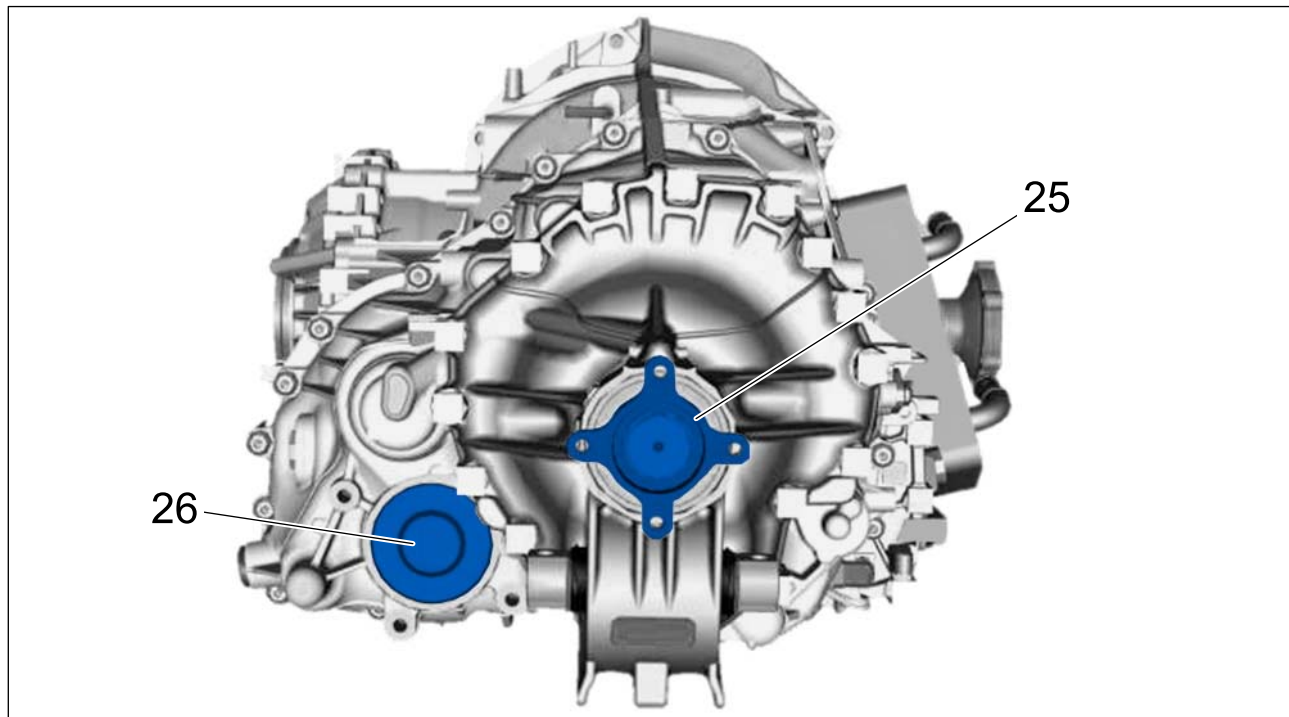
Position	Oil leak	Cause	Repair measure
⇒ Front side of transmission -25-	Output flange 25A - 25B	Sealing ring damaged (A)	Replace sealing ring and output flange, see ⇒ Workshop Manual '398255 Replacing cardan flange sealing ring'.
		Output flange leaking (B)	
⇒ Front side of transmission -26-	Cap	Cover damaged	Replace cover, see ⇒ Workshop Manual '374955 Replacing cover'.
