Requested Filter Element Replacement in Connection with DMTL Replacement

Models	Model Year	Model Type	VIN Range	Vehicle-Specific Equipment
Panamera	2017 - 2020	971	N/A	N/A

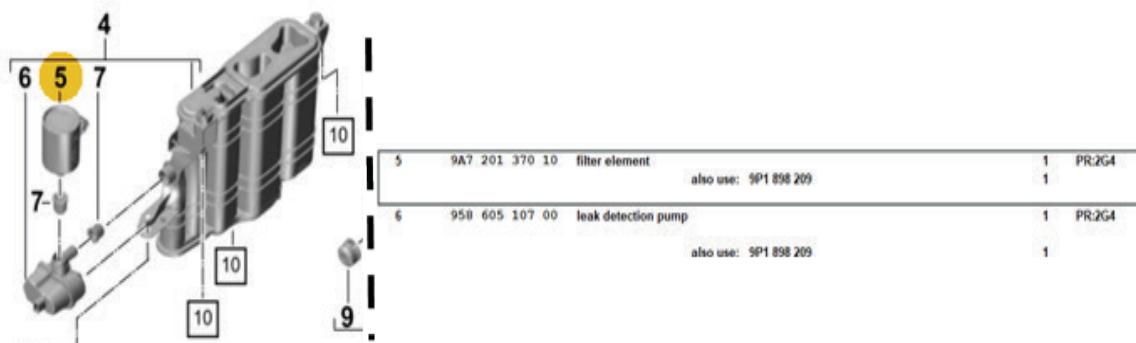
A faulty tank leakage diagnosis module (DMTL) can trigger the malfunction indicator lamp (MIL) for numerous reasons, for example the DME fault "P245000 (002EBO) – Tank leakage diagnostic module, change-over valve – stuck open." In such instances, where the repair necessitates replacement of the DMTL, this ATI kindly requests replacement of the attached filter element shown below. (Both the filter element and DMTL can be replaced by ordering the pre-assembled unit represented by Assembly "4" in Figure 1.)

Figure 1 - Filter element requested for replacement with the DMTL

In the same PQIS entry and warranty request to replace the DMTL to properly repair the vehicle, please replace the filter element (Part 5) shown below. (Only 1 "repair kit for the evaporative emission canister" 9P1 898 209 is necessary.)
