TECHNICAL SERVICE BULLETIN

Turn Signal Lamps Inoperative After LED Control Module Replacement

20-2322
15 September
2020

| Ford 2020 Police Interceptor Utility |

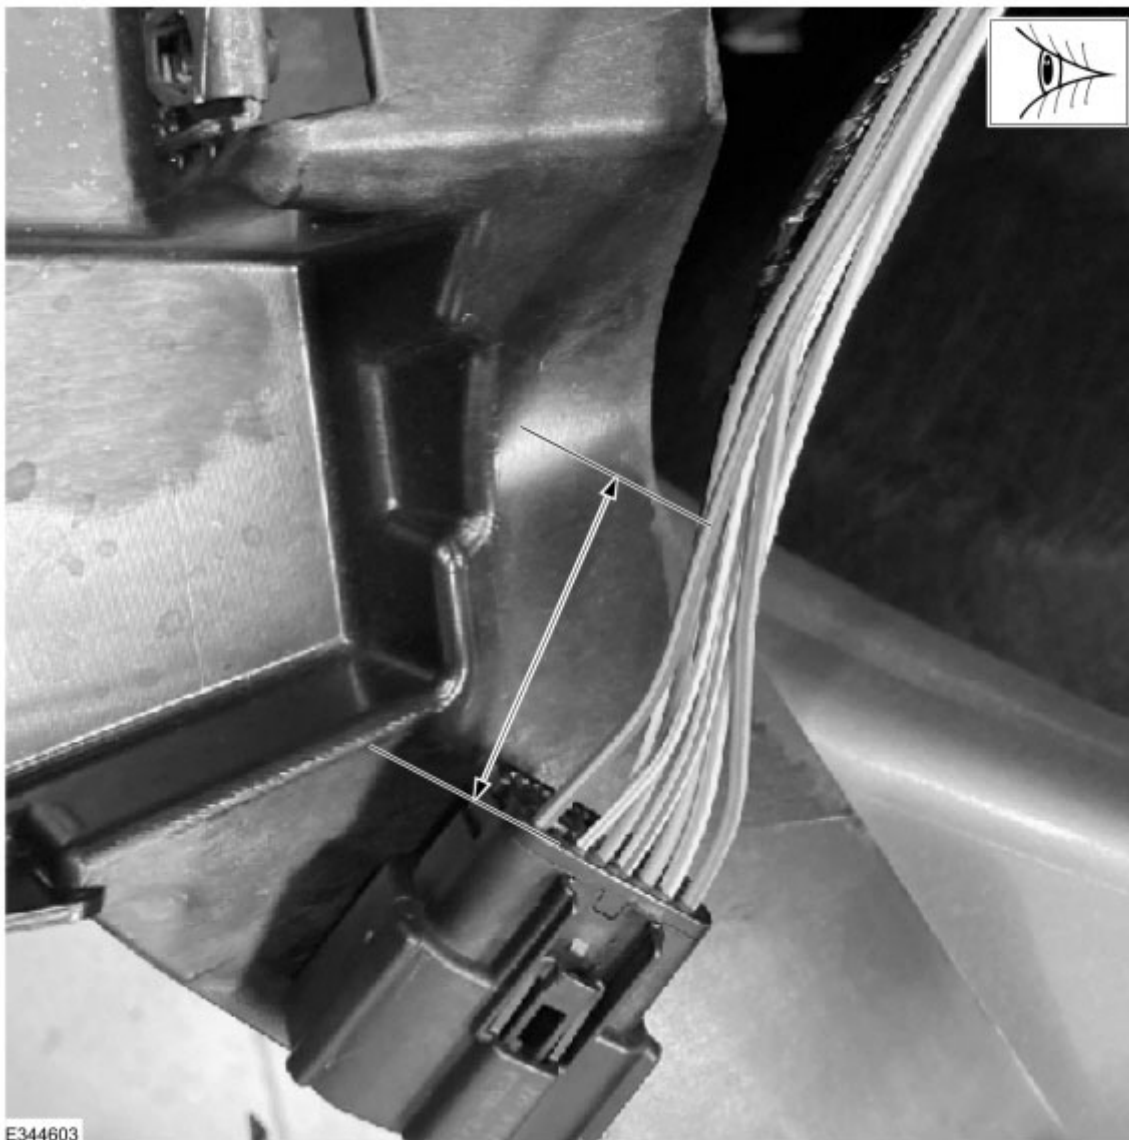
Figure 1 - Left side

Issue: Some 2020 Police Interceptor Utility vehicles may exhibit inoperative turn signal lamps after replacement of the light emitting diode (LED) control module. This may be due to a lack of initialization caused by incomplete wiring circuits. To correct the condition, follow the Service Procedure to splice the needed circuits into the wiring harness of the affected side of the vehicle.

1. Remove the affected headlamp assembly. Refer to Workshop Manual (WSM), Section 417-01.
2. For vehicles where the left side is affected, update the left side wiring.
 - (1). Remove 2 wiring terminals from the wiring service pigtail connector.
 - (2). Install the terminals into connector C1284, pins 9 and 14. Refer to Wiring Diagram, Cell 085-4.
 - (3). Cut the wire to circuit GD120, pin 8 on connector C1284, 76.2 mm (3 in.) from the connector.
 - (4). Solder splice wires from pins 8, 9, and 14 to circuit GD120. Refer to Wiring Diagram, Cell 005. (Figure 1)
