TECHNICAL SERVICE BULLETIN

Illuminated ABS And/Or Stability-Traction Control Lamp With DTCs C0031, C0034 And/Or C0051 - Built On Or Before 2-Sep-2020

20-2323
18 September
2020

Ford 2020 Escape
Lincoln 2020 Corsair

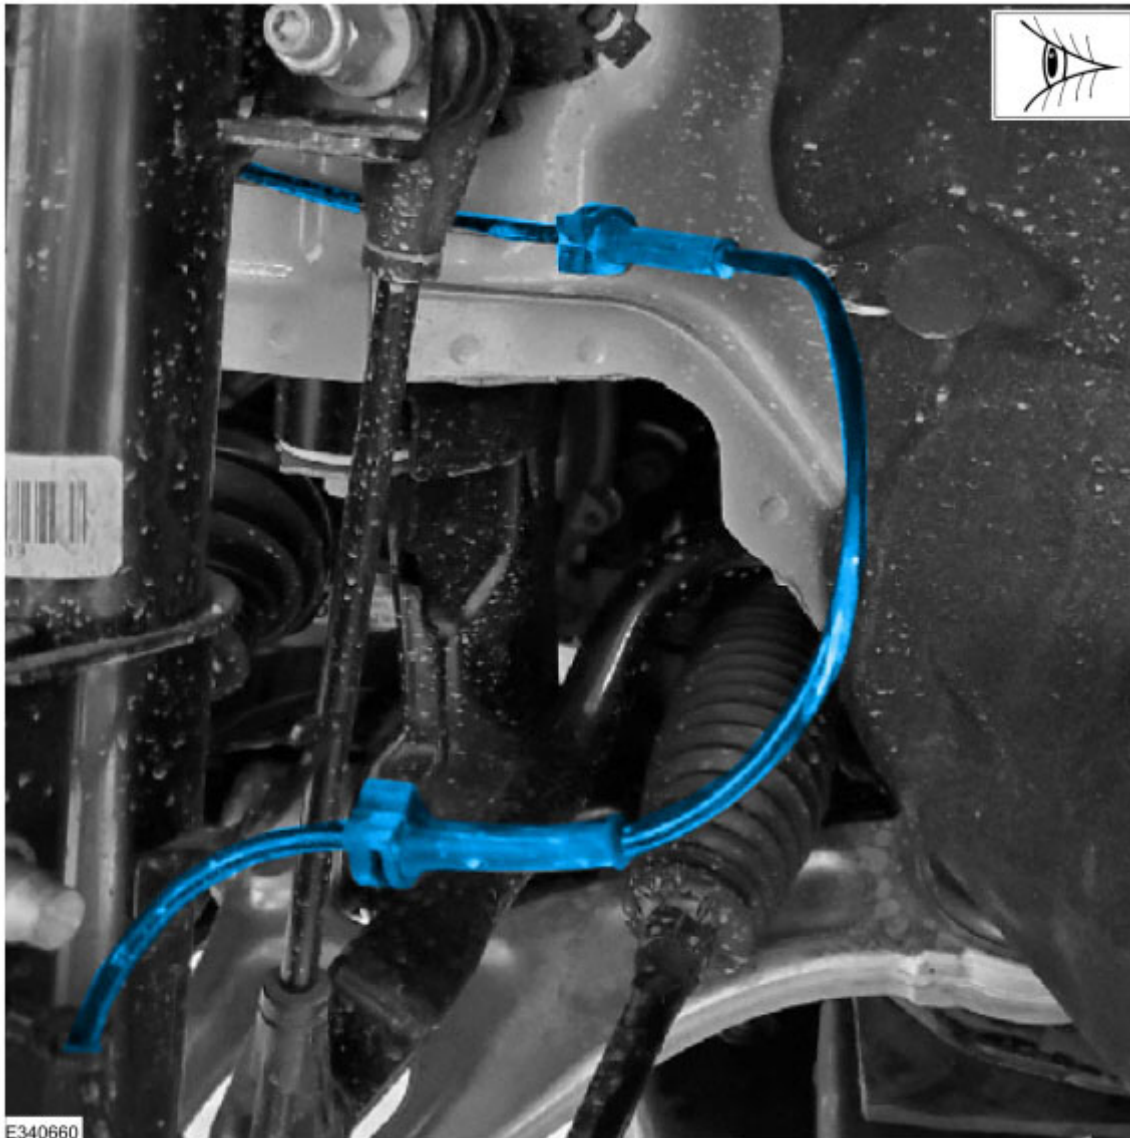
Figure 1

Issue: Some 2020 Escape/Corsair vehicles built on or before 2-Sep-2020 may exhibit an illuminated anti-lock brake system (ABS) and/or stability-traction control lamp with diagnostic trouble codes (DTCs) C0031, C0034 and/or C0051. This may be due to the ABS wheel speed sensor harness rubbing on the front wheels. To correct the condition, follow the Service Procedure steps to inspect the ABS wheel speed sensor harness and install the pigtail service kit.

1. Remove the front wheels. Refer to Workshop Manual (WSM), Section 204-04A.
2. Visually inspect the ABS wheel speed sensor harness located in the front wheel opening area. Are the front wheels rubbing against the wire harness? (Figure 1)
 - (1). Yes - continue to Step 2.
 - (2). No - this article does not apply. Refer to WSM, Section 206-09.

3. Repair the affected wire harness using the service pigtail. Follow the instructions included with the pigtail kit.
