# TECHNICAL SERVICE BULLETIN

## A-pillar Trim Panel Twisted - Built On Or Before 23-Sep-2019

**20-2250**  
21 September  
2020

Ford 2020 Escape
---------------------

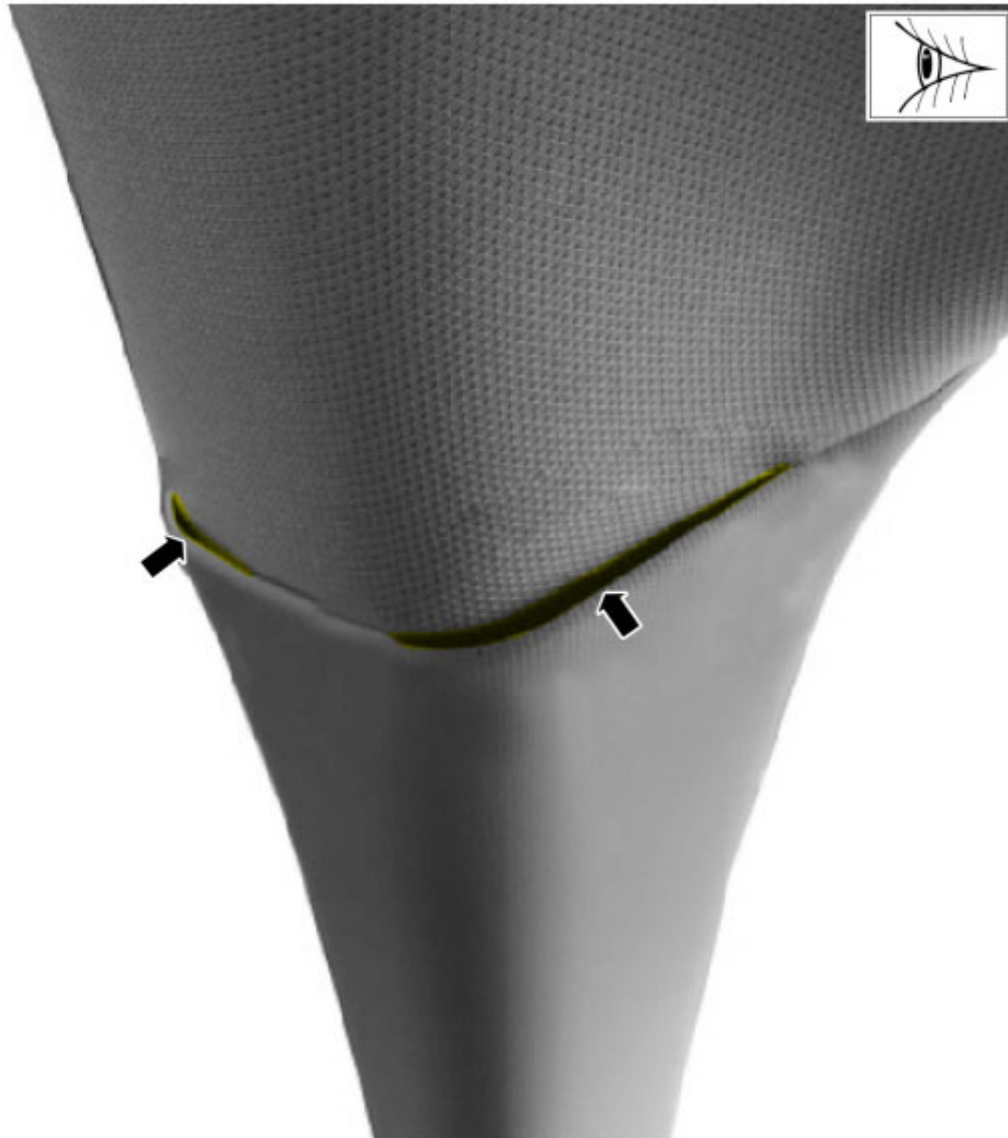
Figure 1

**Issue:** Some 2020 Escape vehicles built on or before 23-Sep-2019 may exhibit a condition where the A-pillar trim panel appears twisted at the top of the panel. This may be due to the attachment of the A-pillar trim panel to the A-pillar bracket. To correct this condition, follow the Service Procedure steps to replace the A-pillar trim panel and the A-pillar bracket.

1. Is the A-pillar trim panel twisted as shown in Figure 1?
