## FIELD SERVICE CAMPAIGN – 20107

18 September 2020

Air Conditioning (A/C) Refrigerant Charge

International® HX® Series built 10 June 2019 thru 27 August 2019

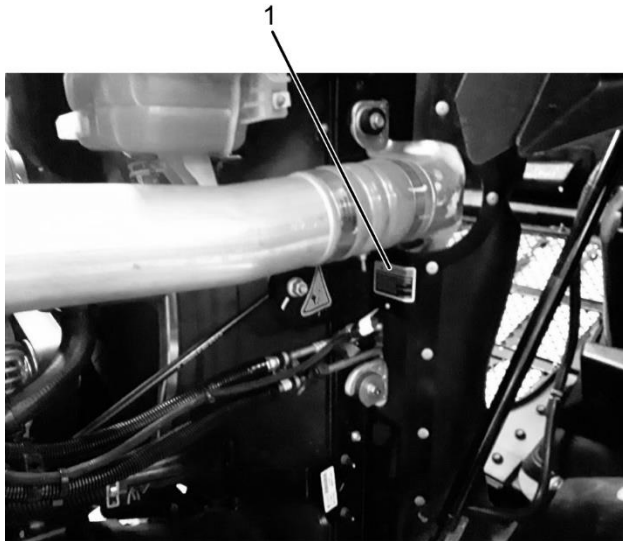
**Figure 1. Label**

The A/C refrigerant system may be overcharged resulting in excessive cooling fan operation and reduced fuel economy. All other vehicles built during this period have either been repaired prior to shipment or determined to not require this repair.

1. Label location
7. Locate existing label on upper passenger-side of cooling package (Figure 1, Item, 1).
8. Clean existing label and surrounding area of any dirt / grease.
9. Peel backing off new label.
10. Apply new label directly over existing label. Smooth out ripples.
11. Charge refrigerant system to 2.5 lb as specified on new label installed in Step 10. Refer to appropriate technician manual for detailed instructions.
12. Close and latch hood.
13. Remove wheel chocks.
