Complaint - Front Side-Section Trim Panel on Driver's Side Sticking Up: Rework Door Sill Trim (144/20)

Model Line: **Taycan (Y1A)**

Model Year: **As of 2020**

Subject: **Front left side-section trim panel**

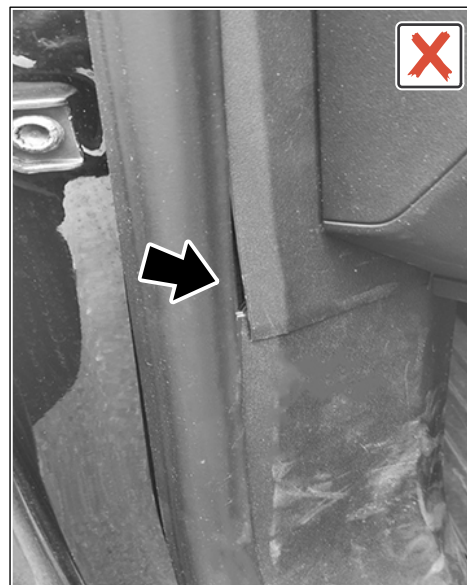
Front left side-section trim panel

Information: Due to an unfavorable position of the main wire harness, this can be pressed against the driver's side door sill trim. As a result, the front left side-section trim panel sticks up
 ⇒ *Front left side-section trim panel.*

Remedial Action: Secure left front door sill trim to the dashboard using tie-wraps.
