92-20-01TT - Windshield Wiper Operation with Fault B12D600, May Occur in Heavy Rain

Release date: 09/29/2020

Model(s)	Year	Eng. Code	Trans. Code	VIN Range From	VIN Range To
Jetta	2018 - 2020	All	All	All	All

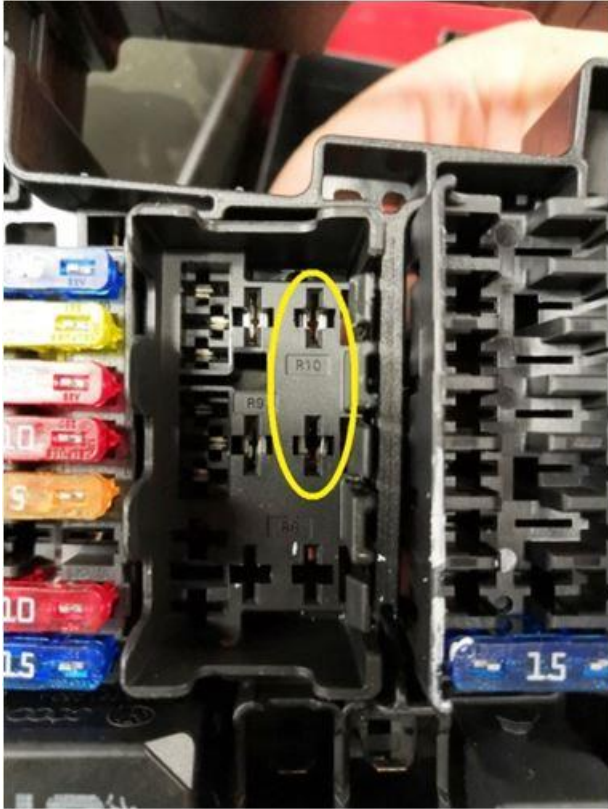
Figure 1

Wipers may have an operational issue, which may occur in heavy rain. Faults may include but are not limited to B12D600, U014100, U112100, U111000.

Inspect the wiring for wiper relay 1 -**J368**- and wiper relay 2 -**J369**- at the under the hood relay panel. Test the terminals by performing a pin drag test, including the connecting circuit between these relays (Figure1). If a terminal issue is found for this connecting circuit, install a new connecting circuit, (Figure 2) with new terminals. See Repair Group 97 in Elsa.
