**2873N0 Eliminating drive symptoms: Reworking crankshaft pulse sender
(Engine difficult to start and rough-running/SY2113)**

Model Year: **As of 2012 up to 2014 Sports Cars (9x1)**

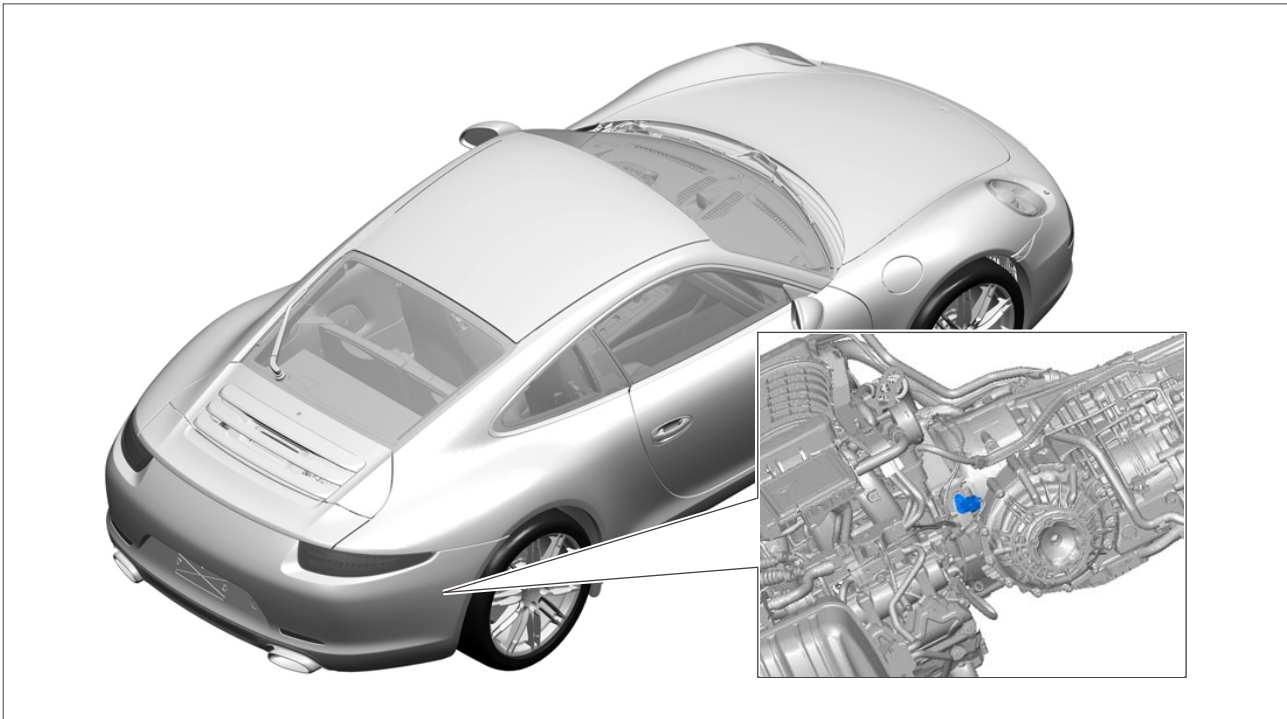
Figure 1

The crankshaft pulse sender signal can be misinterpreted under certain operating conditions due to unfavourable tolerances between the crankshaft pulse sender (also referred to as 'speed sensor') and sensor wheel.

1. **Before doing any other work**, check that the spacer is already fitted on the crankshaft pulse sender.
You can do this using a mirror, for example.
⇒ **Spacer is already fitted: End of action required.**
2. Remove crankshaft pulse sender, see Workshop Manual
⇒ '287319 Removing and installing crankshaft pulse sender - section on "Removing"'.
3. Fit spacer (Part No. 991.606.912.00) between the transmission housing and crankshaft pulse sender.
4. Install crankshaft pulse sender, see Workshop Manual ⇒ '287319 Removing and installing crankshaft pulse sender - section on "Installing"'.
