09/25/2020
CAL FTL 54-012

Subject: New Cascadia 29A Battery Cable Re- location

**Models Affected: New Cascadia vehicles built from January 1,
2017 through September 18, 2020**

Work Instructions

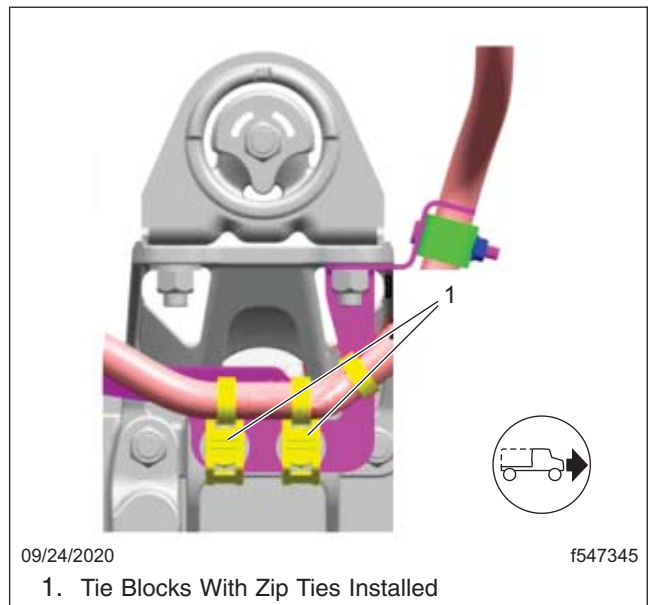
Fig. 5, Secured Battery Cable

1. Tie Blocks With Zip Ties Installed

6. Ensuring the cable remains mounted on top of the stud, install the front piece on the middle clamp and secure the nut.
7. Install two tie blocks and two zip ties on the front-cab-mount bracket bolts to prevent rubbing. See [Fig. 4](#) and [Fig. 5](#)
