Subject: RATTLE NOISE FROM FRONT SUSPENSION WHEN DRIVING OVER BUMPS	Bulletin No.: 02-006/20
	Last Issued: 09/02/2020

2019-2020 Mazda3 (Japan built) with VINS lower than JM1BP*****166377 (produced before January 25, 2020)

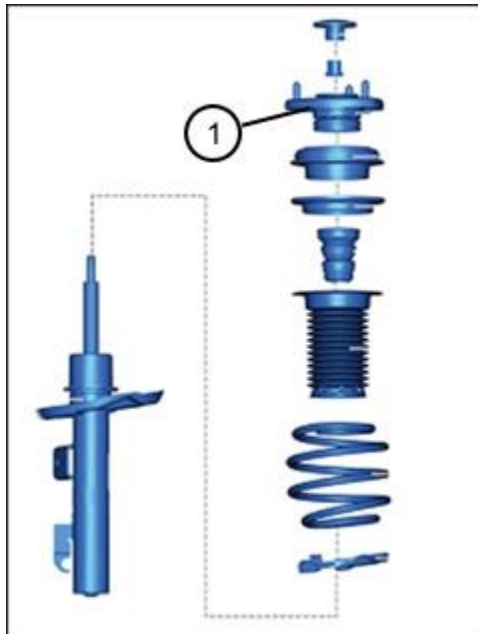
Some vehicles may exhibit a rattle noise from the front suspension when driving over bumps or on a road with a wavy surface. The noise may be caused by the mounting rubber (1) because of insufficient clearance between the rubber and the metal bracket of the mounting rubber during the assembly process. To correct this issue, the mounting rubber has been modified to ensure the proper clearance.

- If the noise is similar to the attached sample sound file, replace the concerned side of the front mounting rubber with a modified one according to the instructions on MGSS (FRONT SHOCK ABSORBER AND COIL SPRING DISASSEMBLY/ASSEMBLY).

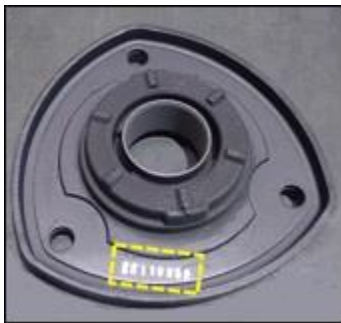
NOTE: Modified mounting rubber BCKE-34-380B is of the same part number as before, but with the production date stamped in white letters on the back of the part. The modification has been implemented from Nov. 21, 2019. Sample picture shows back of the mounting rubber.
