Popping/Crackling from the Speakers; Display Blank

Supersedes 20-031, dated June 18, 2020, to revise the information highlighted in yellow.

Year	Model	Trim Level	VIN Range
2019-20	RDX	ALL	ALL

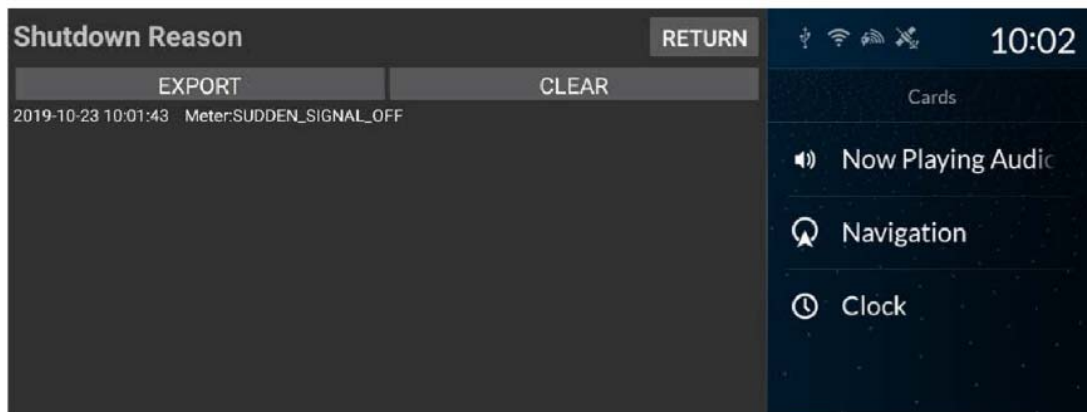
In this example, the cause of the failure can be identified as **Meter:SUDDEN_SIGNAL_OFF**.
