MODEL  
2018MY  
Rio (SC)

NUMBER  
PS671

DATE  
September 2020

### POTENTIAL LOW OIL PRESSURE DUE TO DOWEL PIN NOT FULLY SEATED

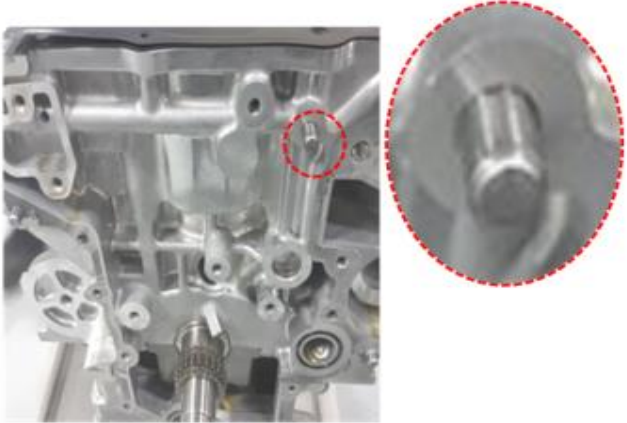
Good	No Good

<p><b>Exceeds 8mm</b></p>
Measures 7-8mm. OK.	Measures 9mm>. Adjust as required.

This Pitstop provides information regarding a potential low oil pressure warning light 'ON' on some 2018MY Rio (SC) vehicles, produced from August 3, 2017 through November 6, 2018, which may be due to the oil pressure leaking past the timing tensioner chain dowel pin. If the dowel pin is not fully seated as described in this publication, measure and adjust the pin height as required between 7-8mm (pin length is 14mm).
