MODEL
2021MY
K5 (DL3a)

NUMBER
210

TECHNICAL SERVICE BULLETIN

SERVICE ACTION: CONSOLE SQUEAK NOISE INSPECTION AND REPAIR (SA436)

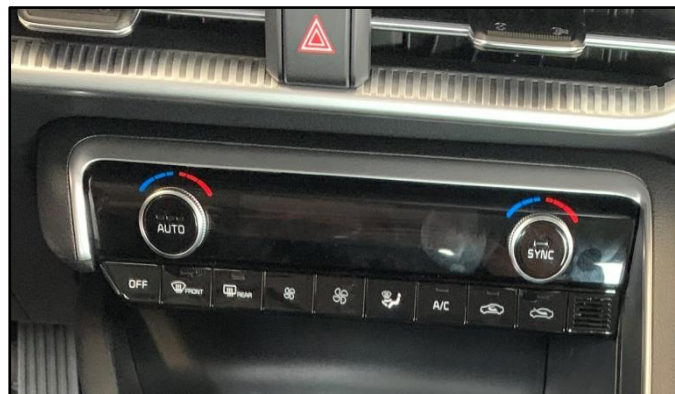
This bulletin provides information regarding a potential squeak noise between the Heating Ventilation Air Condition (HVAC) controller and the floor console upper garnish on some 2021MY K5 (DL3a) produced from March 25, 2020 through September 7, 2020. Follow the inspection procedure to confirm if the squeak is present. If the squeak is present, technicians are instructed to apply Tesa® Tape to the right corner of the HVAC controller face. Before conducting the procedure, verify the vehicle is included in the list of affected VINs.

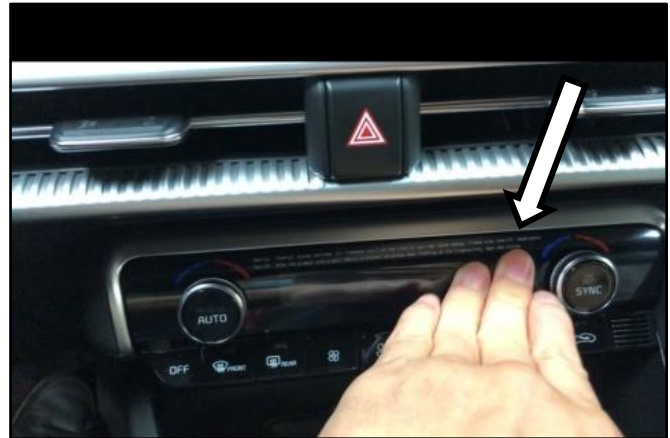
1. Inspect the HVAC controller for squeak by pushing in on the right upper corner of the HVAC controller in the location shown.

If the HVAC controller does not exhibit a squeak noise, no further action is required.

If the HVAC controller squeaks during inspection, follow the Repair Procedure outlined below.
