GROUP	MODEL
ELE	2021MY K5 (DL3a)
NUMBER	DATE
207	September 2020

TECHNICAL SERVICE BULLETIN

SERVICE ACTION: FRONT PASSENGER VENTILATED SEAT HARNESS INSPECTION AND REPLACEMENT (SA434)

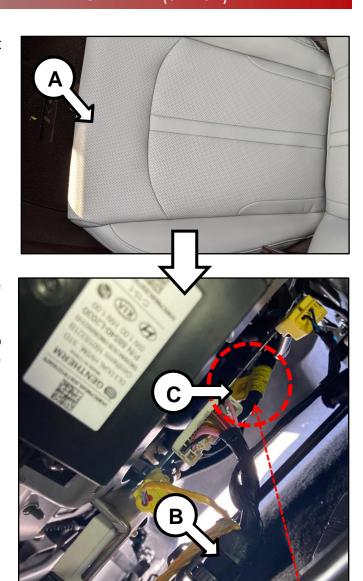
1. Underneath the front passenger seat cushion (A) locate the seat harness (B).

- 2a. Locate the harness tag (C) which may be either 'white' or 'yellow' in color.
- 2b. If the tag (C) is 'white' in color (OK), no further action is needed. This service action is complete.

2c. If the tag (C) is 'yellow' in color (NG), proceed to the seat harness 'Replacement Procedure' outlined on page 3.

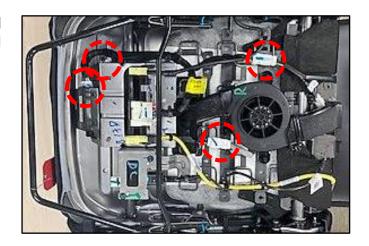
- 1. Save radio presets and disconnect the battery negative (-) cable.
- Remove the front passenger seat by referring to the "Body (Interior and Exterior → Front Seat → Front Seat Assembly → Repair procedures" chapter in the applicable Shop Manual on KGIS.
- 3. Turn the seat upside down and disconnect the four (4) electrical connectors shown.

- 4a. Detach the four (4) seat harness retaining clips shown and remove the seat harness.
- 4b. Replace the front seat harness with the 'white' colored tag seat harness P/N: 88651 L3060 in the reverse order of removal.
- Reinstall the front seat in the reverse order of removal.
- 5. Reconnect the battery negative (-) cable.
- 6. Confirm seat ventilation is operating as designed.
