MODEL  
2021MY  
K5 (DL3A)

NUMBER  
092 (Rev 2, 09/03/2020)

## TECHNICAL SERVICE BULLETIN

SUBJECT: **SERVICE ACTION: HOOD RELEASE CABLE,  
INTERCOOLER CLAMP AND WINDSHIELD SIDE MOLDING (SA431)**

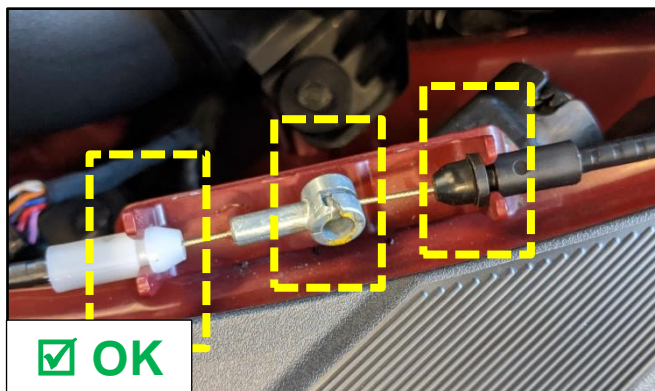
- 7a. Check the hood release cable coupler is attached properly and that the two cable attachments (black and white ends) are fully inserted into the mounting bracket(s).

Photo sample is OK.

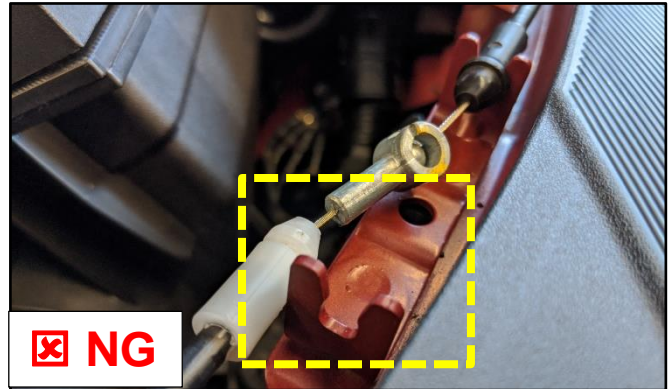
- 7b. If the cable is not fully inserted into the bracket (NG), be sure to align and press down firmly.

**Note:** Listen for click to confirm it is secured in place, OK. (Refer image shown on step 7a).

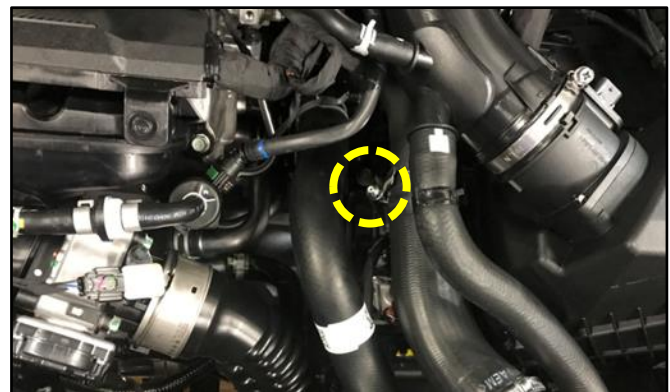
- 1a. Locate the upper intercooler hose clamp (A).

A loose intercooler hose connection may trigger a MIL ON with DTC P017200 - System too rich (Bank 1).

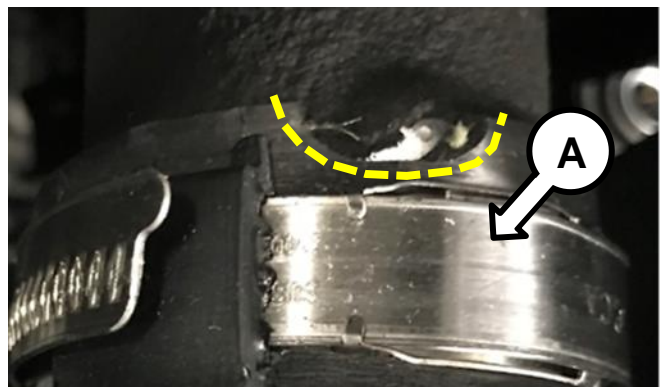
- 1b. Inspect the intercooler hose clamp (A) to intercooler tube connection. Ensure the hose is properly installed to the locating dimple and the hose clamp is squarely positioned around the hose.

- If the hose clamp or hose is NOT positioned as described, proceed to Step 1c/d.
- If the hose is properly installed, proceed to Step 2a.

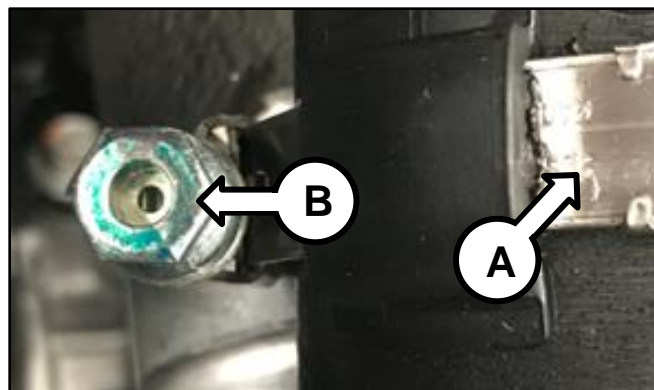
- 2b. If the hose clamp (A) break away nut head (B) is present:

- Tighten the hose clamp break away nut (B) until the nut head breaks off the clamp
- Pull on the intercooler hose to verify that the hose is secure. This action is now complete.

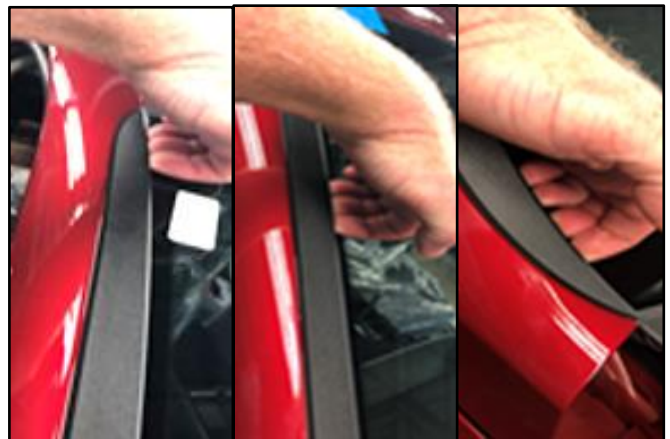
- 2a. Check if the windshield trim molding is not flush to the A-pillar or is loose. Lightly pull on the following areas shown.

**\* NOTICE**  
If any area is not flush or is loose, follow the re-install procedure below.
