Technical Service Bulletin

Subject: POOR FITTING REAR DOOR WEATHERSTRIPS	Bulletin No.: 09-029/20
	Last Issued: 09/03/2020

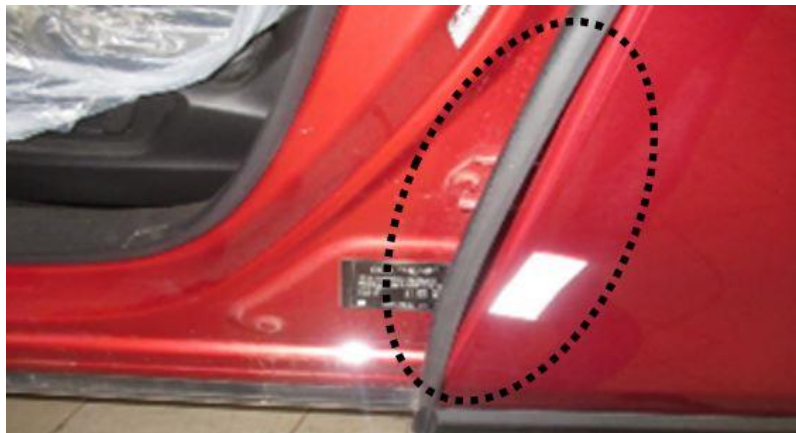
Some vehicles may exhibit poor fitting rear door weatherstrips at the lower/front location. The weatherstrips may be deformed by frequent contact with passengers entering and exiting the vehicle, causing the weatherstrip joint to become enlarged. The enlarged weatherstrip joint does not grip the door panel tight enough when it is refitted.
